钢基身管内镀铬层下的激光淬火 基体界面腐蚀与铬层剥落

INTERFACIAL CORROSION AND SPALLSTION OF Cr-PLATED COATING ON A GUN BARREL STEEL SUBSTRATE PRE-TRATED BY LASER SPIRALY QUECHING

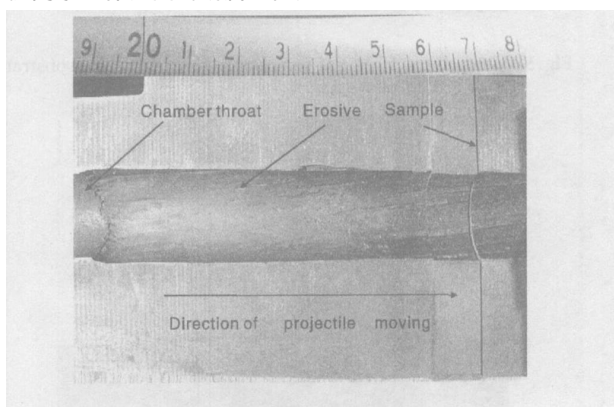
Fig. 2 Location of sample selected

为了揭示铬层下的基体界面高温气体腐蚀与铬层剥落的关系,取靠近烧蚀区,没有铬层剥落的部位为分析试样。具体取样位置如图 2 所示。利用线切割设备取样后,对试样进行磨、抛光。

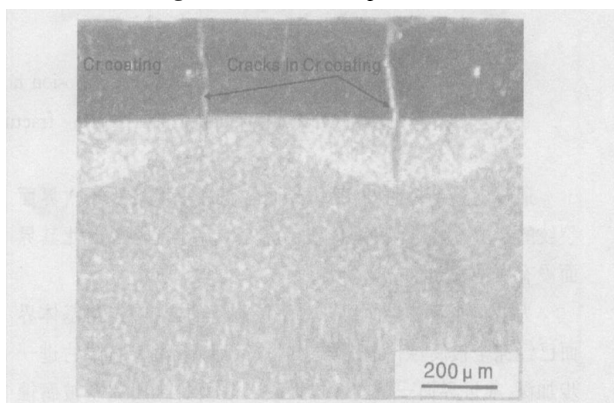
Fig. 3 Morphology of cracks extending from Cr-coating into substrate

对抛光后的试件,用 0.3 % 的硝酸酒精溶液(体积比)进行轻腐蚀,能够显示出激光淬火区即可,得到图 3 所示的光学图片。图 3 表明:激光淬火区和未处理区上的铬层都断裂,并且断裂后的铬层表面裂纹沿铬层厚度方向扩展和进入基体,这些进入基体的裂纹为火药气体对基体界面的腐蚀提供

了通道。

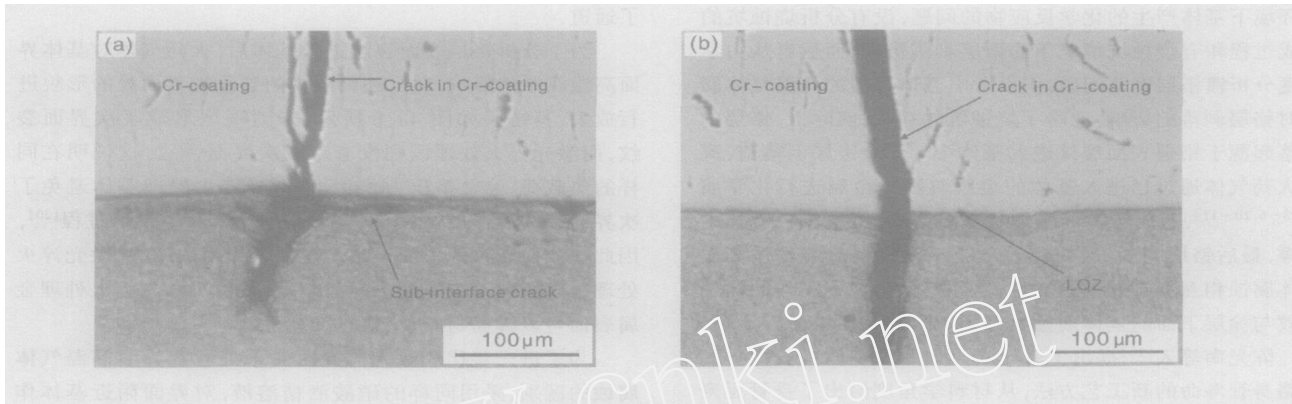
Fig. 4 Sub - interface crack (a)Original substrate ,(b) Laser quenched zone(LQZ)

为了分析铬层表面裂纹进入基体后,火药气体对基体界面高温腐蚀的影响,对上述铬层中的裂纹在界面处的形貌进行放大,其结果如图 4a、b 所示:未处理区形成了次界面裂纹,而激光淬火处理区则没有形成次界面裂纹。这说明在同样的热载荷、弹丸挤压力作用下,激光淬火处理基体避免了次界面裂纹的形成。由于身管失效是一个低周疲劳过程^[20],因此次界面裂纹的形成也是多次载荷作用的结果。激光淬火处理区之所以没有形成次界面裂纹,是由于激光淬火处理金属表面可以提高材料疲劳强度的缘故^[21~24]。

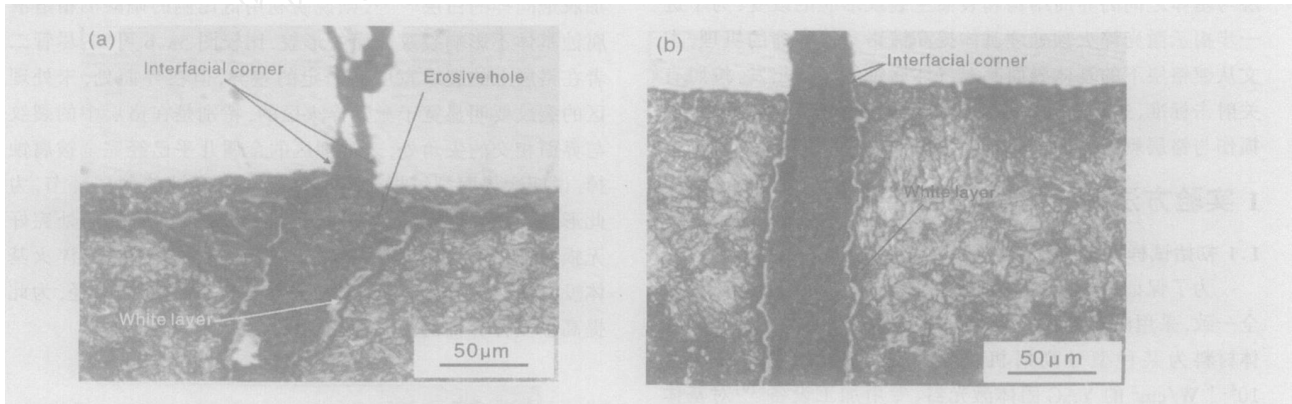
Fig. 5 Comparison of hot gas corrosion resistance of the substrate at interface. (a) Original substrate) ,(b) Laser quenched zone(LQZ)

为了进一步比较激光淬火区和未处理区界面高温气体腐蚀的区别,采用同样的硝酸酒精溶液,对界面附近基体作进一步腐蚀,得到的图 5 表明:在裂纹表面上存在和 120 mm 加农炮同样的白层^[3~6],则说明利用低比例的硝酸酒精溶液腐蚀基体不影响裂纹表面的形貌。比较图 5a、b 可知:尽管二者在铬层上的裂纹宽度有一定的差异,但在界面处,未处理区的裂纹要明显宽于激光淬火区的,特别是在铬层中的裂纹与界面相交的尖角处,未处理区的金属几乎已经完全被腐蚀掉,说明次界面裂纹根部是基体金属耐腐蚀的薄弱环节,为此形成了图 5a 所示的烧蚀坑。而激光淬火区的尖角处完好无损,延续了铬层表面裂纹的宽度。这说明由于激光淬火基体没有形成次界面裂纹,未给高温气体提供腐蚀路径,为此提高了基体界面的耐腐蚀能力。

通过上述分析可知,基体界面的腐蚀程度取决于次界面裂纹的形成.激光淬火基体没有形成次界面裂纹,因此其界面没有腐蚀损伤.

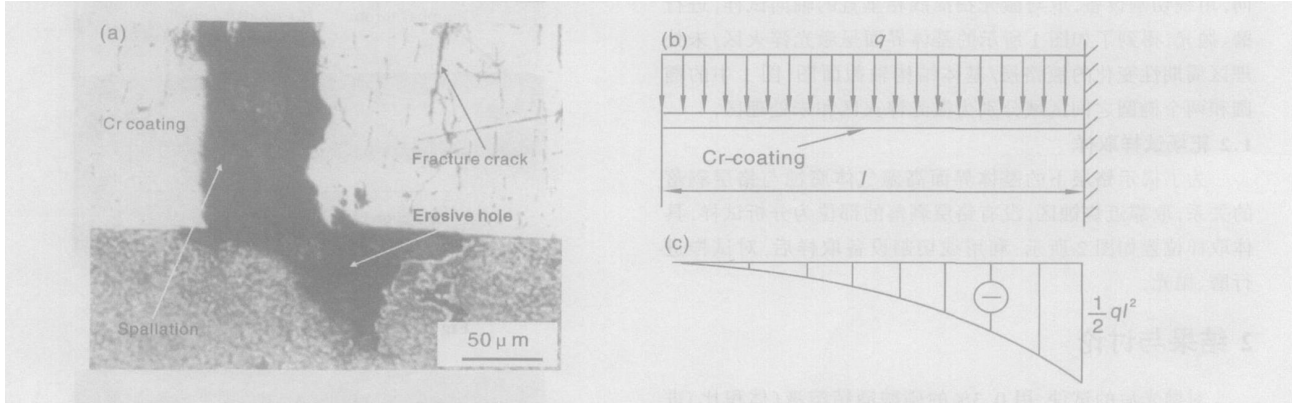
Fig. 6 Cr-coating spallation on erosion hole (a) A schematic of Cr-coating spallation ,
(b) Mechanical model of Cr-coating fracture and spallation ,(c) Bending moment graph

为了阐明基体界面腐蚀对铬层剥落的影响,选用基体界面已经完全被腐蚀掉的试样.如图 6a 所示:随着腐蚀的进一步加深,靠近界面一侧的次界面裂纹表面的金属完全被腐蚀掉,最后只剩下被架空的铬层.为了分析如图 6a 所示的被架空的铬层剥落机理,将被架空的铬层模拟成一个悬臂梁,其

力学分析示意图如图 6b 所示.当考虑火药气体压力和弹丸挤压联合作用时,将这些作用近似用沿梁长度方向均匀分布的载荷(载荷密度为 q)表示,被架空铬层的长度为 l .由材料力学理论^[25]和图 6c 可知:在固定端处的铬层存在最大负弯矩($M_{\max} = ql^2/2$)和该处的铬层表面受到最大拉应力作用,则在火药气体和弹丸作用下,当最大拉应力大于铬层断裂强度时,铬层表面先断裂,后铬层完全断裂导致铬层剥落,形成了图 6a 左侧的剥落部分.

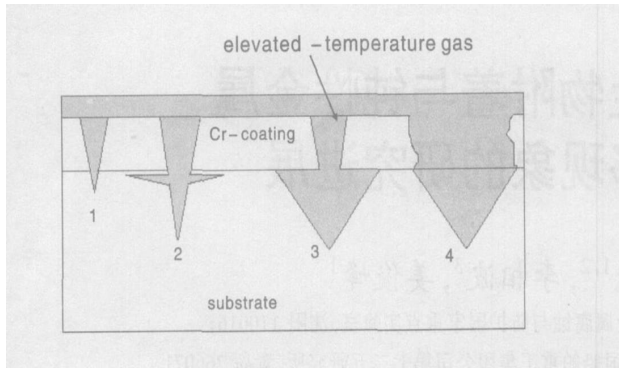
Fig. 7 Schematic of substrate erosion and Cr-coating spalling

为了进一步明确基体界面腐蚀与铬层剥落过程,结合上述分析,给出图 7 所示的基体烧蚀与铬层剥落示意图,图中阴影部分为高温火药气体。图 7 表明:在高温火药气体、弹丸挤压作用下,先导致铬层表面裂纹,表面裂纹扩展成铬层中裂纹并扩展入基体,高温火药气体通过该裂纹和基体接触(图中 1);随着上述裂纹在基体内进一步扩展,在基体内形成次界面裂纹,高温气体腐蚀对铬层中裂纹和次界面裂纹的表面(图中 2);当基体界面金属完全被腐蚀掉后,在基体内形成烧蚀坑(图中 3);最后烧蚀坑上的铬层发生了断裂剥落(图中 4)。这和忽略高温气体腐蚀作用的界面剪切剥落^[9]情况完全不同。

由于激光淬火处理基体可以抑制次界面裂纹的形成(不出现图 7 中 2 所示的现象),避免了基体界面被腐蚀,故没有形成烧蚀坑,基体仍然对铬层起到支撑作用,故提高了铬层的抗剥落能力。
