## Circular brass foil failed by plugging opposite to direction of incident laser beam

### Abstract

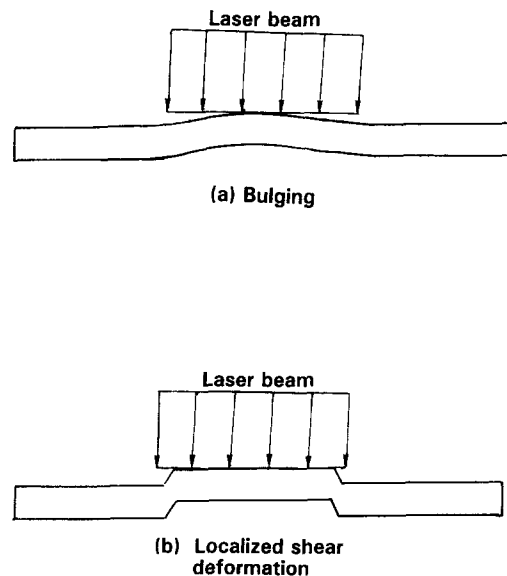
Illustrated schematically in Figs. 4 and 5 is the evolution of specimen failure. Fig. 4(a) shows bulging of the brass foil at the earlier stage of

Fig. 4. Initial stages of damage evolution: (a) bulging and (b) localized shear deformation.

laser irradiation. Note that this occurs towards the side of the incident laser beam where the temperature would be higher. Considerable shear deformation occurs around a rim near the outer edge of the laser beam. This leads to the softening of the material due to intense heating.

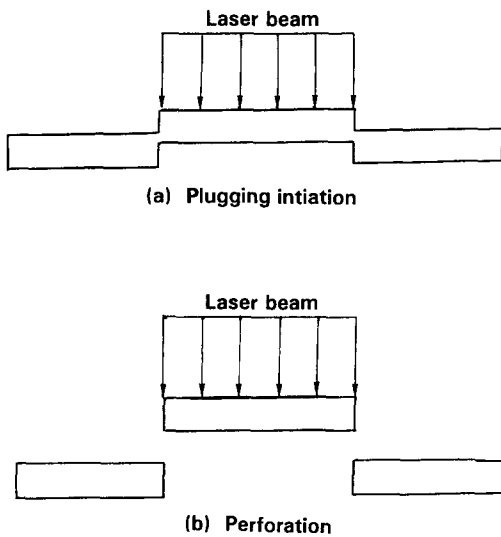
Fig. 5. Final stages of failure: (a) plugging initiation and (b) perforation.

Further intensification of the energy around the periphery of the laser beam leads to the initiation of plugging and final perforation which are shown in Figs. 5(a) and 5(b), respectively. The plugging mode of failure is customarily known to be associated with metal projectiles penetrating through metal targets in plate form [3,4]. A plug of the target material is ejected in the direction of the energy source that is the moving projectile. In the case of an incident laser beam, plugging occurred opposite to the incoming direction of the energy source. The initial bulge occurs on the side with higher temperature that determines the direction of plugging.
