Effect of ceramic coating thickness on fracture behaviour of coating structure under thermal shock cycles

ABSTRACT

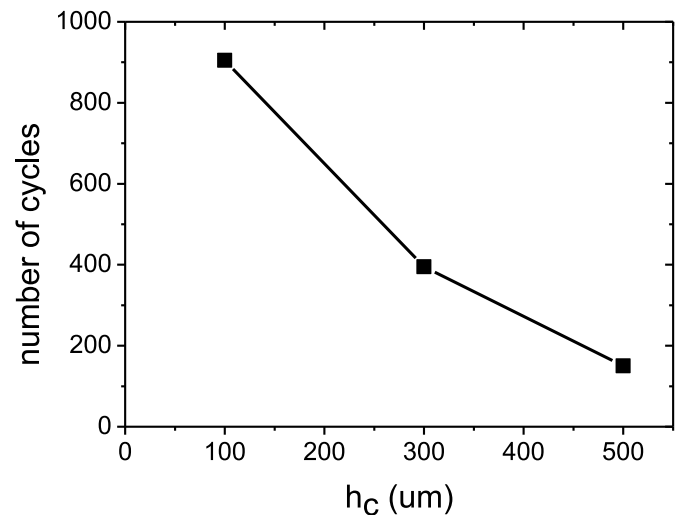
Fig. 2. The number of thermal shock cycles of coating spallation decreases with increasing coating thickness.

Fig. 1 compares the surface morphology of coating spallation for three different coating thickness samples after thermal shock cycles. The figure shows that for the 100 μm coating, only local spallation occurred even after 905 cycles. However, block spallation occurred at lower cycles for the 300 and 500 μm coatings. For the 500 μm coatings, severe spallation appeared after only 150 cycles. It is clear that the number of cycles to coating failure decreases with increasing coating thickness, the number of cycles at failure of 500 μm coatings is only 16.6% of that of 100 μm coatings as shown in Fig. 2.

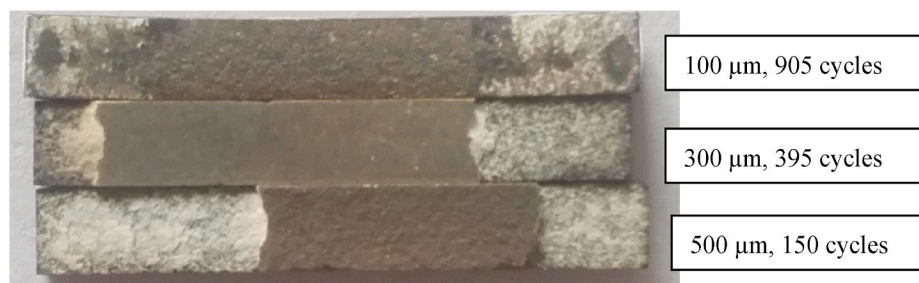
Fig. 1. Surface morphology of coating spallation for coating thicknesses of 100, 300, and 500 μm from top to bottom, respectively, after 905, 395 and 150 thermal shock cycles.

cracking initiates from the ends, in agreement with the experimental results (Fig. 1).

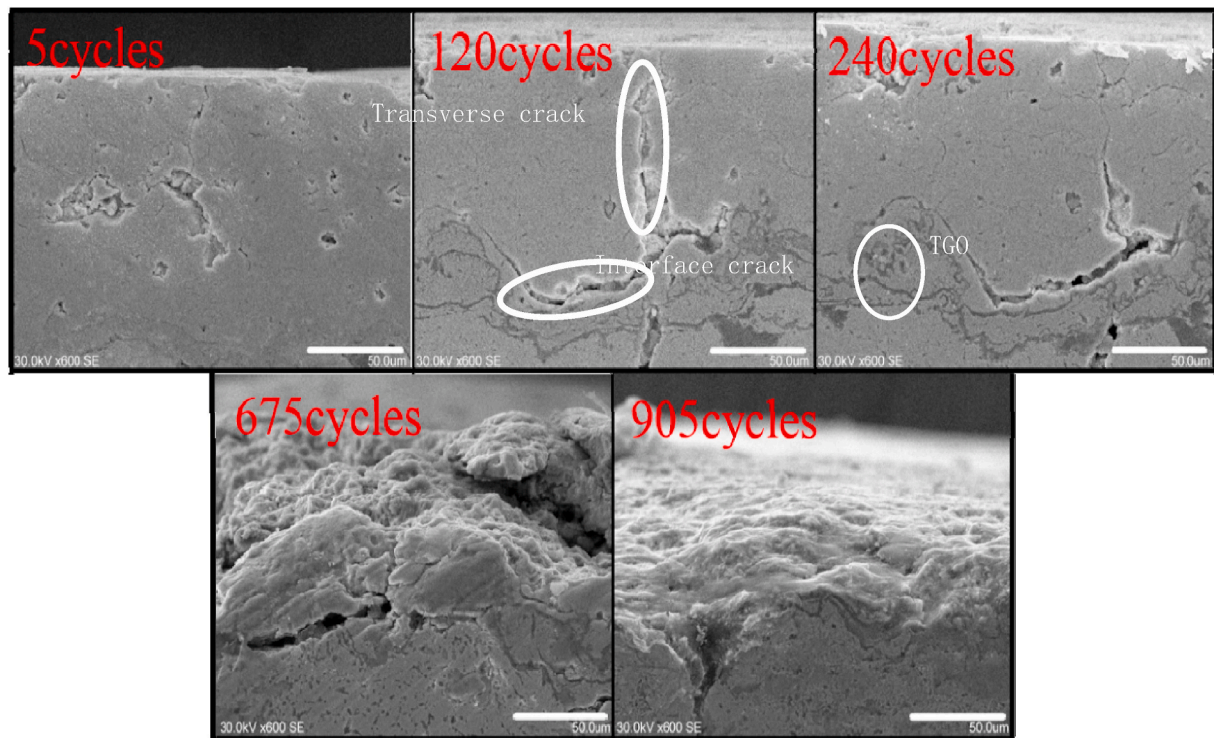
Fig. 3. Cross-section of 100 μm -coating sample obtained by SEM after different numbers of thermal shock cycles with the scale bar of 50 μm .

To understand the crack origin, the evolution of the cross-sectional microscopic morphology of the coating samples after thermal shock cycling is shown for the three different coating thicknesses in Fig. 3 and Figs. 5 and 6, respectively. Fig. 3 shows that the thermal growth oxide

(TGO) of 1.3 μm formed in the 100 μm coating, and the interface crack occurred near the TGO in addition to the transverse cracks after 120 cycles. The local spallation of the coating occurred at the boundary after 675 cycles, and the thickness of TGO reaches 3.8 μm . The spallation area increased obviously after 905 cycles. Although TGO grows linearly after multiple thermal cycles as shown in Fig. 4 for 100 μm coating samples, the thickness of TGO is smaller than 6 μm , this thin TGO has a positive effect on the resistance against thermal shock as discussed in Ref. [42]. Note that the thickness effect of TGO has been studied, the induced stress increases with increasing thickness of TGO [43,44], especially when the thickness of TGO is larger than 8 μm [43]. Considering TGO is thin here and its effect is not obvious, which will be neglected in the next finite

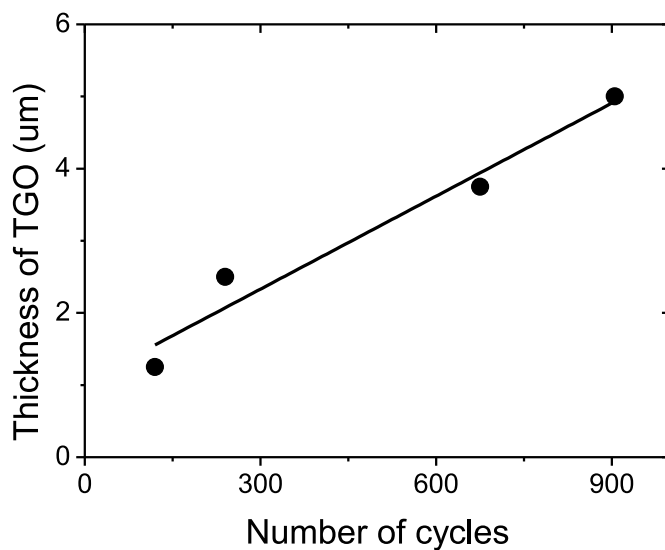
Fig. 4. Thickness of TGO increases with thermal cycles for 100 μm coating sample.

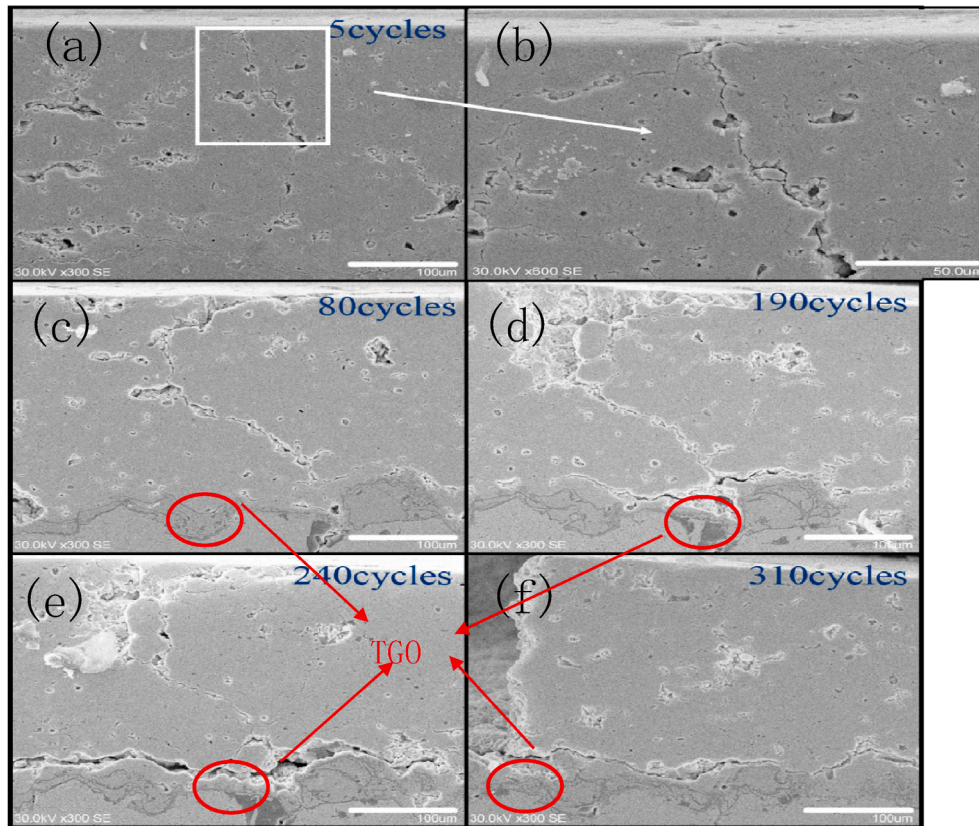
Fig. 5. Cross-section of 300 μm -coating sample obtained by SEM after different numbers of thermal shock cycles with scale bar of 100 μm except for enlargement in (b).

Fig. 5 shows the process from transverse cracking (Fig. 5(a)) to interface cracking of the 300 μm coating, which started after 80 cycles (Fig. 5(c)). The interface crack was clearly observed at the TGO/coating interface after 190 cycles (Fig. 5(d)). The interface crack propagated further after 240 cycles (Fig. 5(e)). The cracks extended through the interface, and the coating spallation occurred at the boundary after 310 cycles (Fig. 5(f)). Fig. 6 shows that the interface crack appeared after 80 cycles for the 500 μm coating (Fig. 6(e)). The cracks extended, and the interface fractured after 120 cycles (Fig. 6(f)). The results indicate that the coating spallation mainly originated from the interface fracture, and the interface crack was often initiated at the boundary (two ends, as shown in Fig. 1) with the stress concentration. To analyse the stress effect, the finite element method was used to calculate the thermal stress evolution and distribution described in the next section.

where T is the temperature, t is time, x -direction is parallel to the substrate surface, and y -direction is along the substrate thickness, referring to point A in Fig. 5 as the origin point. The third type of boundary condition is applied:

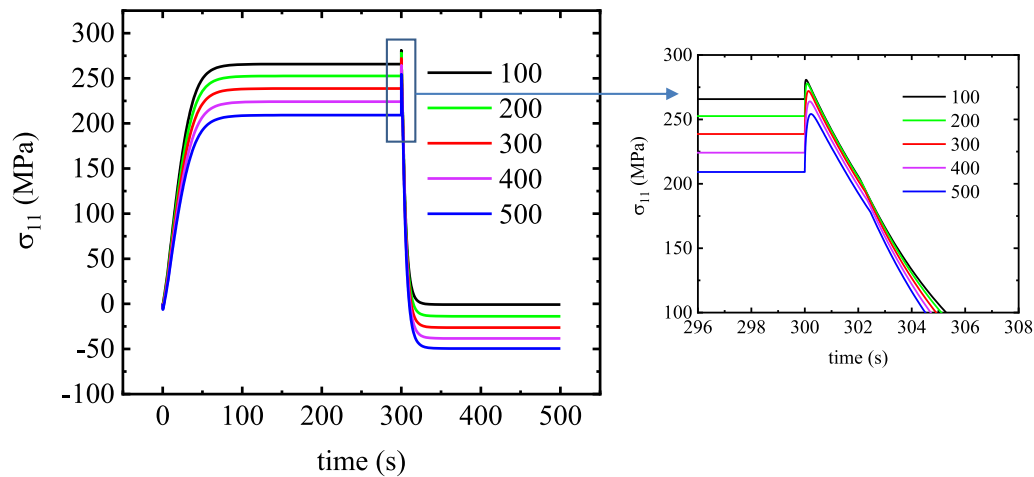
Fig. 8. Normal stress σ_{11} evolution of point C on coating surface for different coating thicknesses (100, 200, 300, 400 and 500 μm).

initially during the heating process and then remains stable up to the initial cooling period. The coating surface is in a tensile stress state in the heating step owing to a thermal mismatch between the coating and the substrate and the smaller thermal expansion coefficient of the coatings. The stable tensile stress (approximately 260 MPa for the 100 μm coating) decreases with increasing thickness of the coatings, which is attributed to the smaller tensile effect from the substrates. The substrates were in a compressive stress state, and the substrate compressive stress increased with increasing thickness of the coatings (Supplementary Fig. 1). During quenching, the normal stress of the coating decreased rapidly after a slight enhancement (see enlarged graph of the zone in Fig. 8) and became compressive, which increased with increasing

thickness of the coatings, owing to the higher temperature gradient in the thicker coatings (Supplementary Fig. 2). The instance of a slight enhancement of tensile stress (20–40 MPa) at the beginning of cooling is attributed to the instant shrinkage of the surface coating. The tensile stress induced transverse cracking in the surface coatings, which was clear and in agreement with the previous analysis [45], especially for the thinner coatings with the higher tensile stress. However, the compressive stress during cooling induced interface cracking between the coatings and the substrates, which is especially evident for thicker coatings with a higher compressive stress of 50 MPa. These results agree with the experimental results [16] and the results of coatings under three-point bending that coating surface cracking dominates in thin coatings and

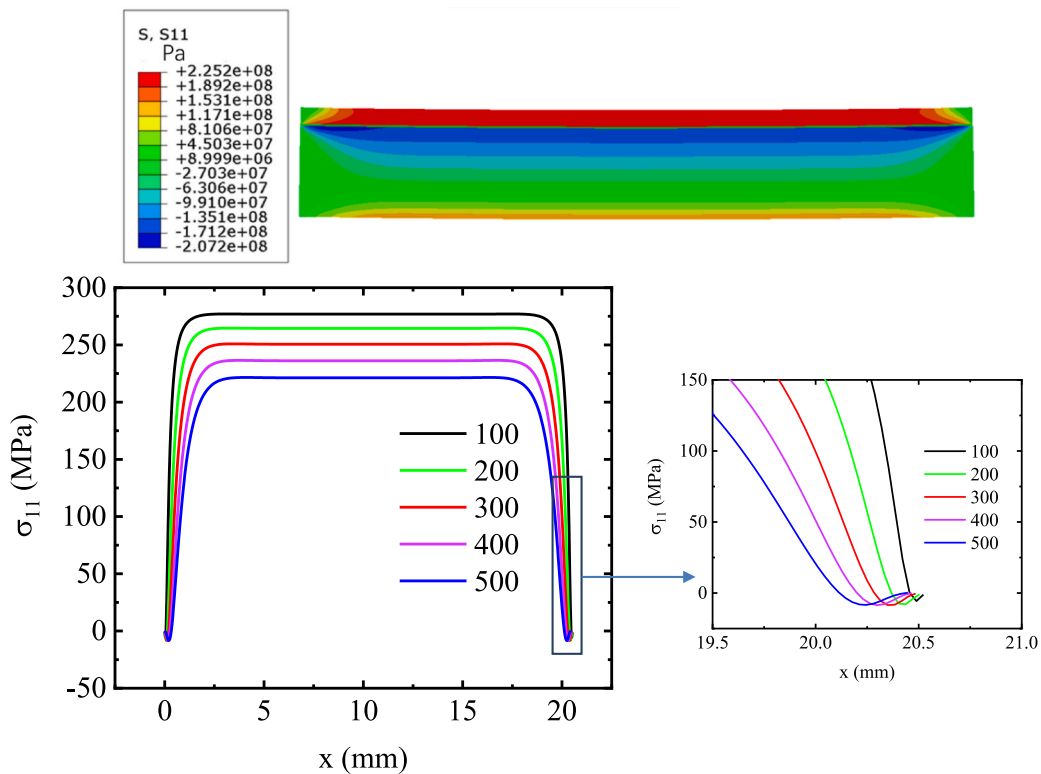
Fig. 9. (a) Normal stress σ_{11} distribution in cross-section of the model with coating thickness of 500 μm , 0.01 s after start of quenching. (b) Normal stress σ_{11} distribution along surface of coatings with different thicknesses (100, 200, 300, 400 and 500 μm).

The normal stress σ_{11} distribution of the coating surface in the x -direction 0.01 s after the start of quenching is shown in Fig. 9. The tensile stress is homogeneous along the surface except at the ends (the confinement effect on the boundary of the substrate is almost neglected and the stress is about zero), and the tensile stress is lower for the thicker coatings (Fig. 9(b)) due to the smaller confinement effect of the substrate, similar to the stress distribution during heating. Fig. 10 shows that the normal stress of the coating surface transformed into a compressive stress 15 s after the start of quenching for the 200 μm , 300 μm , 400 μm and 500 μm coatings, and the stress changed significantly at

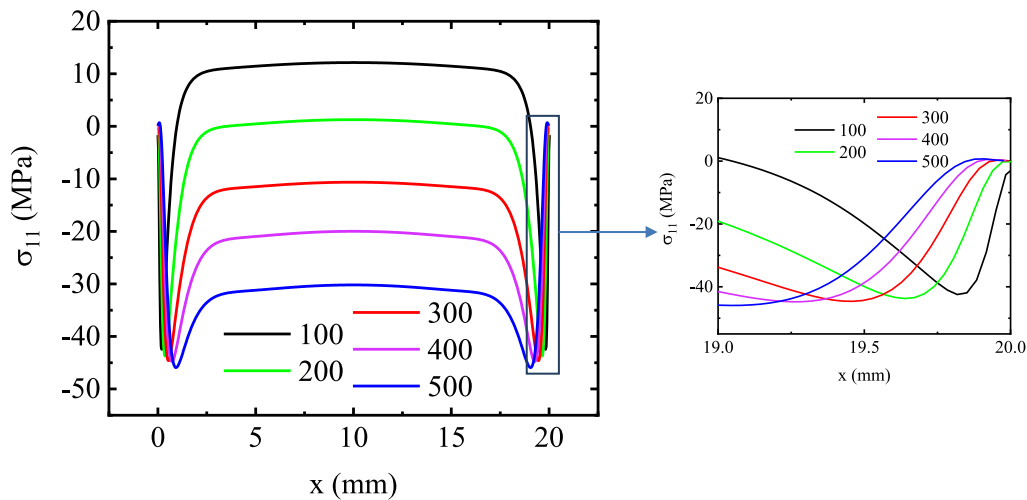
Fig. 10. Normal stress σ_{11} distribution along surface of coatings with different thicknesses, 15 s after start of quenching.

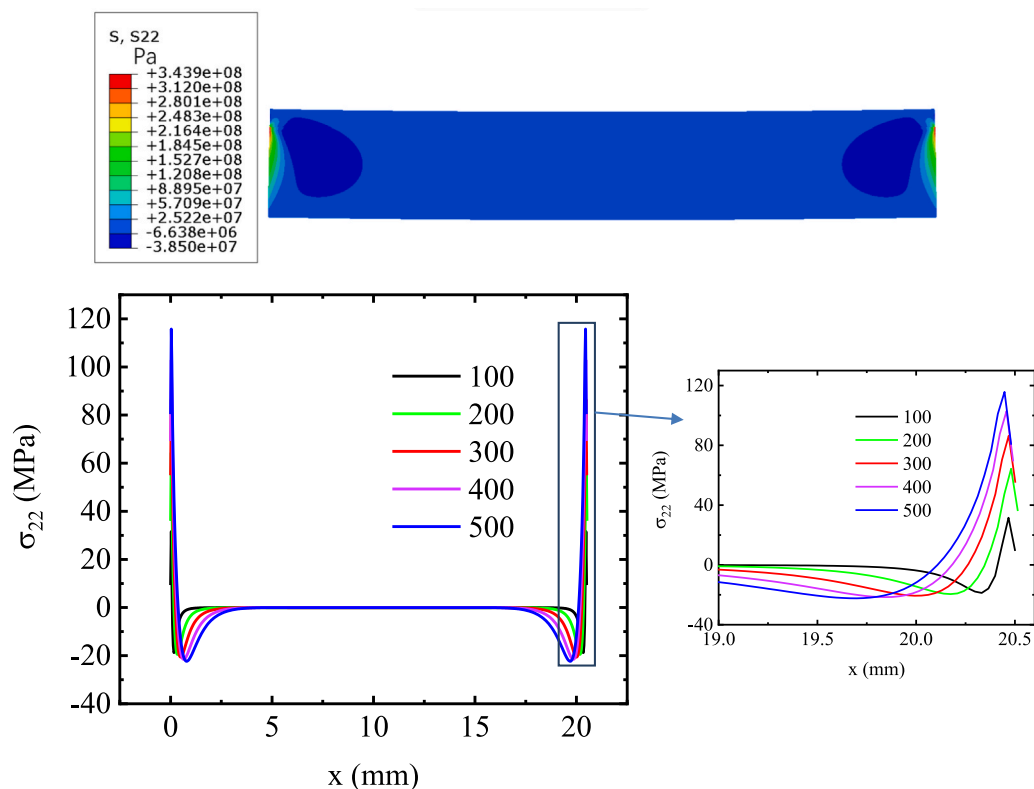
Fig. 11. (a) Normal stress σ_{22} distribution in cross-section of the model with coating thickness of 500 μm , 0.01 s after start of quenching. (b) Normal stress σ_{22} distribution along TC/BC interface for different coating thicknesses (100, 200, 300, 400 and 500 μm).

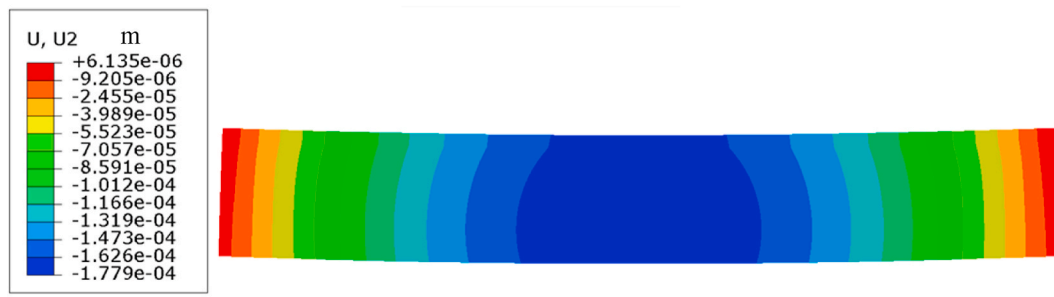
Fig. 12. Displacement U_2 distribution in the model with 300 μm coating after ten thermal shock cycles.

Furthermore, thermal shock cycling for the 300 μm -coating structure was simulated. Fig. 12 shows the displacement u_2 distribution in the y-direction after ten cycles. It is clear that the displacements were more significant at the two ends and the coating was warped up, which is

related to the residual strain in the plastic substrates. As this residual strain increased with thermal shock cycling, coating spallation finally occurred. Fig. 13 shows the normal stress σ_{11} evolution at point C of the coating surface with the number of thermal cycles. It is clear that the change trends of the stress are the same in every cycle, but the maximum tensile stress decreased and the maximum compressive stress increased with increasing numbers of cycles. The residual compressive stress increased from 26 MPa after one cycle to 125 MPa after ten cycles for 300 μm coatings (to 72 MPa for 100 μm and 136 MPa for 500 μm). The compressive stress increased slightly with further continuous cycles. However, there is no obvious change in the normal stress σ_{22} in the y-direction at the interface after several thermal shock cycles, as shown in Fig. 14, implying the normal stress σ_{11} in the x-direction is dominant for thickness effect and the larger compressive stress induced serious interface cracking of the thicker coatings. Because the plastic deformation is irreversible, with the accumulation and increase of the residual stress, the stress at the interface reaches the strength and coating spallation occurs.

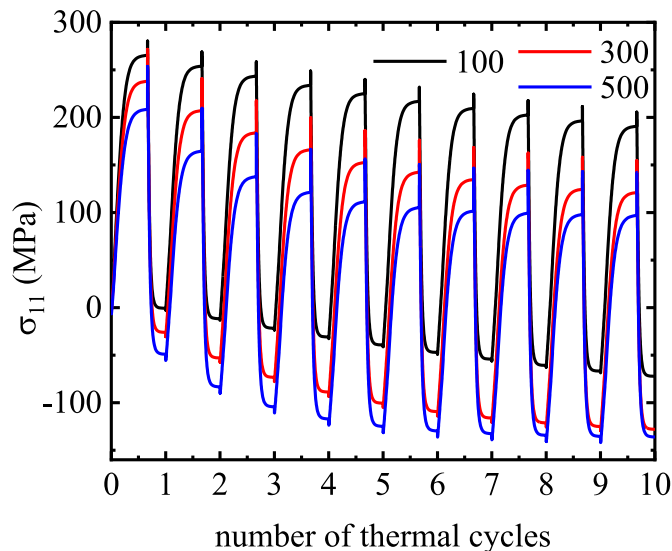
Fig. 13. Normal stress σ_{11} evolution of point C on coating (100, 300 and 500 μm) surface during ten thermal shock cycles.

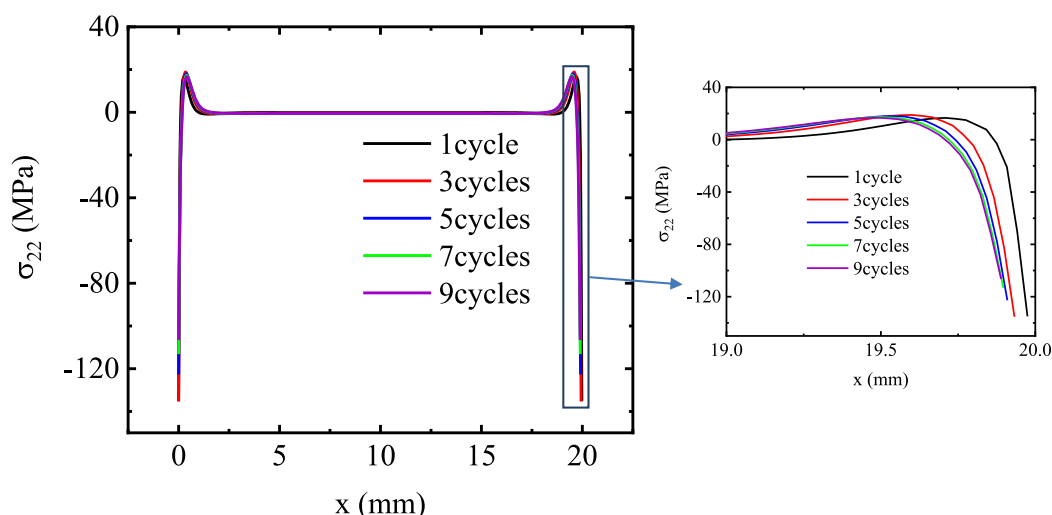
Fig. 14. Normal stress σ_{22} distribution along TC/BC interface for the model with 300 μm coating after different numbers of thermal shock cycles.
