Article

Erosion Performance of TiAlSiN Coatings Prepared by High-Power Pulsed Magnetron Sputtering

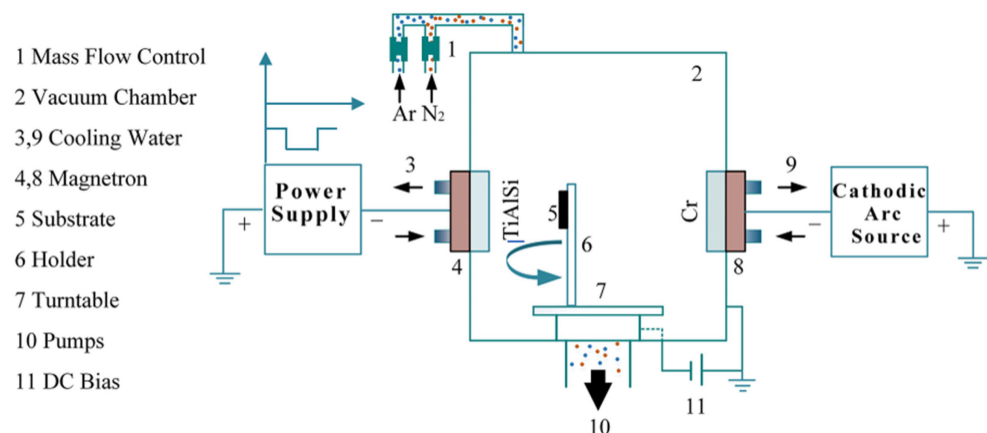
Figure 1. Schematic diagram of the experimental deposition system.

TiAlSiN coatings were prepared on a titanium alloy TC6 substrate by a high-power pulse magnetron sputtering discharge system in a home-made hybrid deposition apparatus. This chamber was equipped with a magnetron sputtering system and a cathodic arc evaporation scheme, which has a high efficiency in pumping, heating, or deposition processes. Two targets, the sintered Ti_{0.46}Al_{0.45}Si_{0.09} mosaic target and Cr target, were used in our deposition. The sintered Ti_{0.46}Al_{0.45}Si_{0.09} mosaic target, as described in our previous reports [20,21,28], was vertically installed in front of magnets and controlled by a magnetron

sputtering system. The effective work area of the target was an ellipse of $\sim 95 \text{ cm}^2$ (12 cm in the major axis \times 10 cm in the minor axis). The magnetic field was designed with a Type II unbalanced structure, where the maximum strength parallel to the target surface was $\sim 50 \text{ mT}$. The sintered Cr target was positioned opposite the $\text{Ti}_{0.46}\text{Al}_{0.45}\text{Si}_{0.09}$ mosaic target and equipped with a cathodic arc evaporation scheme, as shown in the schematic diagram in Figure 1. The distances of the substrate-to- $\text{Ti}_{0.46}\text{Al}_{0.45}\text{Si}_{0.09}$ target and substrate-to-Cr target were ~ 8 and ~ 10 cm, respectively. Before coating deposition in the vacuum chamber, the TC6 substrates were mechanically polished to be a mirror with a roughness Ra of less than $0.02 \mu\text{m}$. After that, the TC6 substrates were cleaned with acetone and alcohol in an ultrasonic bath for 10 min successively. They were then dried by compressed air. Glow discharge etching was first carried out at 1.5 Pa Ar pressure, and a direct current bias with 1 kV voltage and duration of 30 min removed contaminants and oxidations from the substrate surface. To enhance the adhesion between the TiAlSiN coatings and TC6 substrates, Cr + CrNx buffer layers were deposited on the substrates by the cathodic arc evaporation scheme with the sintered Cr target. For the translation layers deposition, the substrate bias voltage, arc current of target, and working pressure were maintained at -100 V , 80 A , 0.8 Pa . The thickness of the Cr + CrNx buffer layers was approximately 500 nm . After this process, the substrate was rotated around the center central rotary table to the right, ahead of the $\text{Ti}_{0.46}\text{Al}_{0.45}\text{Si}_{0.09}$ target to start the deposition process of the TiAlSiN coatings. The TiAlSiN coatings were prepared at a gas pressure of 0.8 Pa , pulse frequency of 150 Hz , pulse width of $125 \mu\text{s}$, and substrate bias voltage of -150 V . A direct current (dc) power with a constant value of 0.1 kW was applied on the cathode target during the pulse-off time (a home-made supply) shown in the schematic diagram in Figure 1 to reduce the gas breakdown delay during the glow discharge. During the TiAlSiN coatings deposition, the total pressure of the mixed gas equaled the summation of the partial pressure of the argon (Ar, 99.999% in purity) and nitrogen (N_2 , 99.999% in purity) gases, where Ar and N_2 served as working and reactive gas, respectively. The discharge voltage magnitude of the high-power impulse used in the synthesis of the TiAlSiN coatings varied from -500 to -600 V (-500 V , -560 V , -570 V , and -600 V). These prepared samples were designated as TiAlSiN-500, TiAlSiN-560, TiAlSiN-570, and TiAlSiN-600. The thicknesses of the TiAlSiN coatings were almost the same at around $2 \mu\text{m}$. The deposition rate of the TiAlSiN coating was dependent on the variation of the discharge voltage of the HPPMS. To obtain a consistent thickness of $\sim 2 \mu\text{m}$ for all the coatings, the total deposition time was adjusted according the discharge voltage, as shown in Table 1. During the deposition period of the buffer layer or TiAlSiN coating, the sample holders were stationary facing the corresponding target. The detailed process parameters of the buffer layer and TiAlSiN coatings on the TC6 substrate are listed in Table 2.

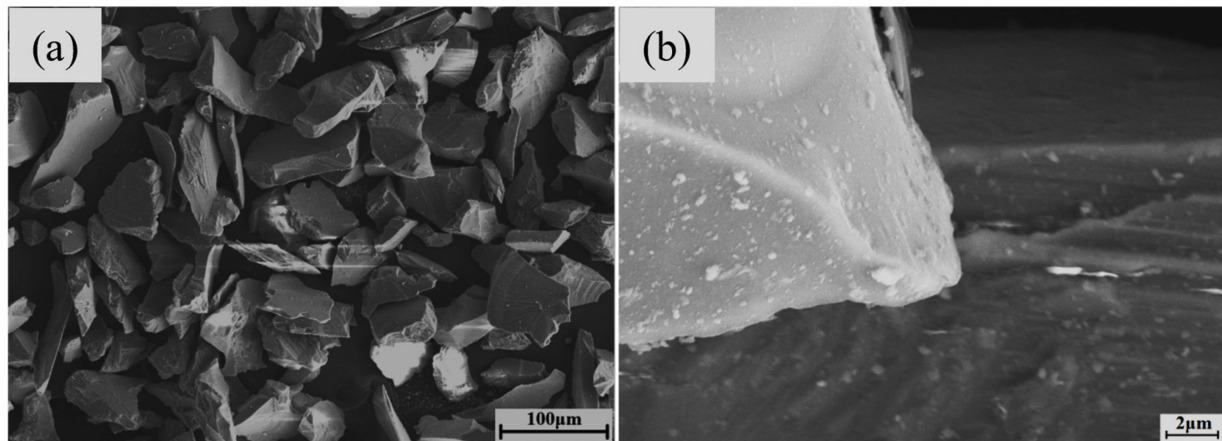
Figure 2. The micro-morphology of angular Al_2O_3 solid particles (a) and the sharp angular geometry of one single particle (b).

The erosion performance of TiAlSiN coatings was evaluated by angular Al₂O₃ solid particles. The sand particle erosion tests were performed at room temperature in a home-made sand blasting tester, which was set up according to the ASTM standard G76-13 [40]. As shown in Figure 2, the sand particles had a sharp angular geometry with a mean size of around 50 μm. The nozzle of the gas blast tester was designed with an inner diameter of 1.5 mm and a length of 50 mm. The distance from the sample's surface to the nozzle end

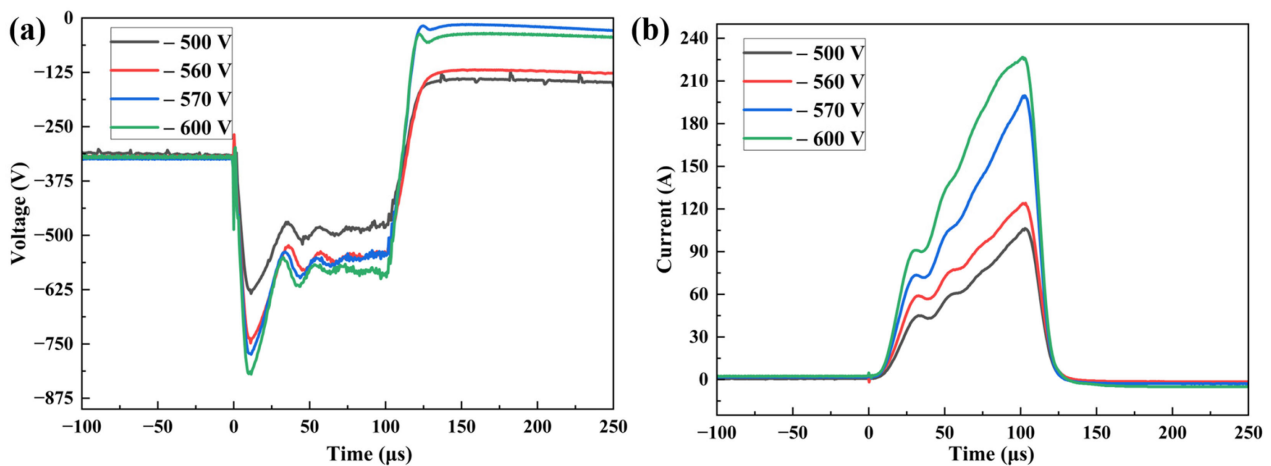
Figure 3. The voltage (a) and current (b) waveform of the $\text{Ti}_{0.46}\text{Al}_{0.45}\text{Si}_{0.09}$ target dependent on discharge voltages.

The discharge characterization of the HPPMS process for the $\text{Ti}_{0.46}\text{Al}_{0.45}\text{Si}_{0.09}$ target in nitrogen atmosphere was recorded by a digital oscilloscope. The discharge current dependent on target voltages is shown in Figure 3. Overall, the peak target current increased from 105 to 225 A with the increase in discharge voltage from -500 to -600 V, which was reasonable. The target current during magnetron sputtering is composed of the collected ion current I_{ion} , plasma electron current I_e , and secondary emission electron current I_{sec} [41]. With the increase in discharge voltage, more secondary emission electrons were ejected from the target and obtained energy as they crossed the enhanced electric field of the plasma sheath. At same time, these abundant high-energy electrons could increase the probability of ionization collisions between the electrons and neutral particles, resulting in the increase in plasma density as well as discharge current.

Nevertheless, the increment in the peak target current was significantly different during the stepwise voltage increase. With increasing the discharge voltage from -500 to -560 V, the peak of the discharge current increased from about 105 to 122 A, with an increment of 17 A. Then the discharge voltage was also increased in 10 V increments, up to 570 V, and the peak target current was increased by an increment of almost 78 A, rapidly arriving at around 200 A. By further increasing the discharge voltage to 600 V, the increment of the peak target current became smaller with a value of ~ 25 A, reaching

approximately 225 A. This phenomenon may be connected with the target's partial poisoning (nitrides redeposition) on the $\text{Ti}_{0.46}\text{Al}_{0.45}\text{Si}_{0.09}$ target surface, which usually occurred during reactive magnetron sputtering [42]. These TiAlSiN nitrides have a higher secondary electron emission yield (SEY) than their metal target [43], contributing to the increase in discharge current. With the further increase in voltage, the SEY of the clean and partially poisoned target both became higher; thereby, the current increment for voltage from -560 to -570 V was larger than that for voltage from -500 to -560 V. However, it seemed that the redeposition rate of these nitrides of around -570 V was slower than that at -560 V, and concomitantly the growth rate of SEY decreased. Accordingly, the increment in the peak target current became smaller for the discharge voltage, from -570 to -600 V.

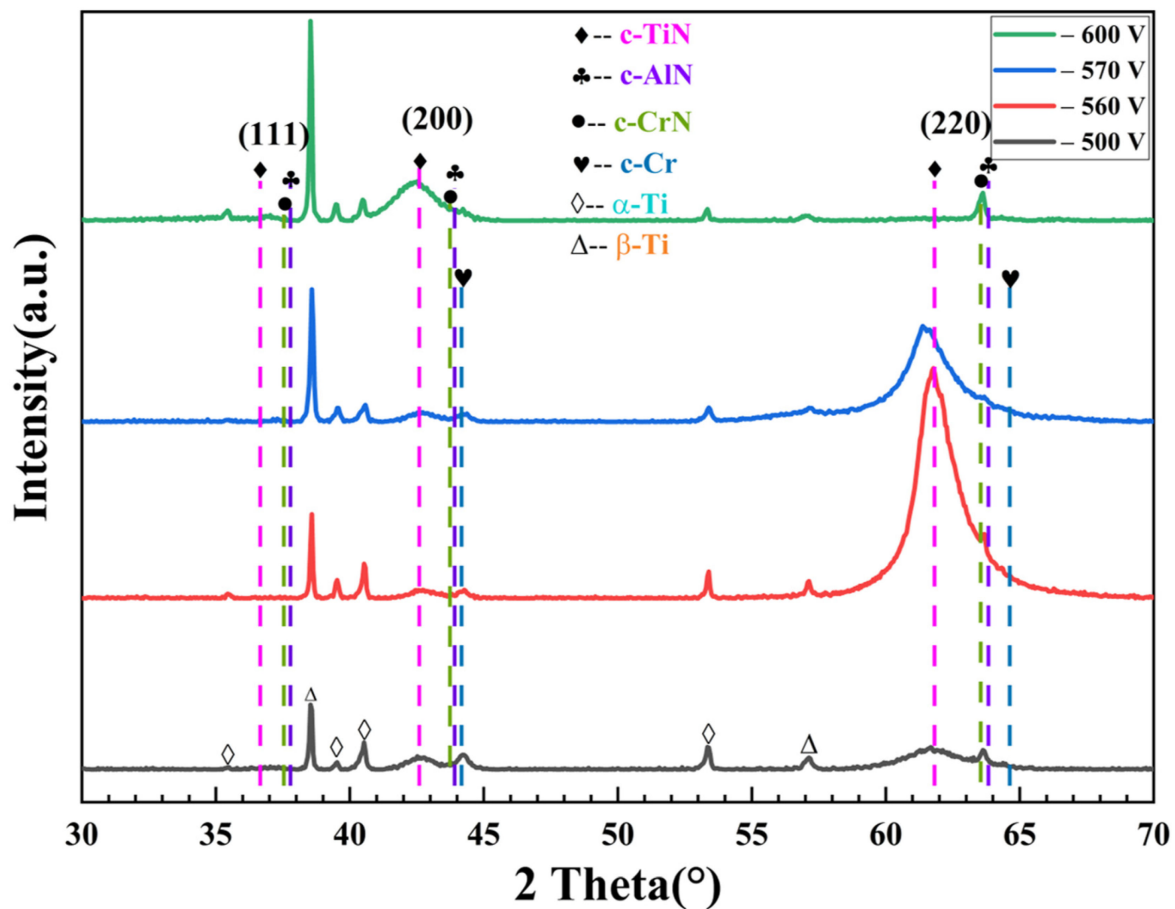
Figure 5. The X-ray diffractograms of the TiAlSiN coatings with various discharge voltages.

The phase constituents of the TiAlSiN coatings fabricated at various discharge voltages were determined by an X-ray diffractometer and are displayed in Figure 5. It is obvious that the TiAlSiN coatings exhibited the diffraction peaks of the standard face-centered cubic TiN (*c*-TiN, #JCPDF38-1420) and cubic AlN (*c*-AlN, #JCPDF25-1495). Meanwhile, the peaks of the buffer layer CrN (*c*-CrN, #JCPDF11-0065), Cr (*c*-Cr, #JCPDF06-0694), and the titanium alloy TC6 substrate (α -Ti, #JCPDF44-1294, β -Ti, #JCPDF44-1288) were also noticed and tagged. All coatings exhibited a NaCl-type crystal structure but with a diffuse scattering peak, which indicated coatings with a nanocrystalline structure. The silicon-related phases could not be matched in the diffraction peaks. Based on the above analysis by XPS, it suggested that Si atoms formed an amorphous Si₃N₄ phase. The XRD and XPS results implied that the prepared TiAlSiN coatings may be nanocomposite structures composed of *nc*-TiN and *a*-Si₃N₄.

With the discharge voltage increase during the deposition process, the prepared coatings presented different crystal structures and preferred orientations. At the discharge voltage of -500 V, the X-ray diffractogram of the deposited coating showed obvious streamed buns peaks, which meant the existence of a large number of amorphous structures. As the discharge voltage increased to -560 V, the coating not only showed the increase in the crystallization properties of the nanocrystals, but exhibited the preferred orientation (220) of FCC structures, which was also reported by Park et al. [49], Molarius et al. [50], and Pelleg et al. [51]. Usually, the preferred orientation in the FCC nitride coating is the outcome of the lowest overall energy, which results from the critical competition between the surface energy and strain energies [51]. The (110) or (111) plane was noted as having the lowest strain energy. As aforementioned, at higher discharge voltage, the ionization degree and energy flux of the reactive particles became higher, which enhanced the ion bombardment

on the growth coating, especially under a bias voltage, and thus increased the strain energies. As a result, the (220) preferred orientation was expected under a higher discharge voltage. When the discharge voltage further increased to -570 V, the intensity of the (220) texture decreased with a broadened FWHM (full width at half maximum) and exhibited a certain degree of left-shifting. Namely, the grain size was refined and the compressive stress was introduced via the further enhanced ion flux and energy. Furthermore, increasing the discharge voltage to 600 V resulted in the (220) texture vanishing completely and a transition of the preferred growth orientation into the (200) plane, which was in agreement with previous studies [52]. Owing to the relative number of atom columns per unit area for (002):(220) with $1:\sqrt{2}$, the [002] provided more open channeling directions for impingement ions to distribute their energy, which means that the (200) plane endured less damage from the strongest ion bombardment. Correspondingly, the (200) plane had a higher survival probability at the discharge voltage of -600 V, conducive to its preferred orientation. A leftward shift was also noticed on the X-ray diffractograms, which may have resulted from increased residual stress in the deposited coating under the strong ion bombardment [51,53,54]. At the same time, *c*-CrN displayed the (220) preferred orientation owing to the preferential sputtering and collisional dissociation N_2^+ ions at this intense ion bombardment [39]. The crystal structures and preferred orientation of the prepared coatings were effectively tailored by the discharge voltage of the HPPMS pulse.

Another point should be noticed that with the increase in ion flux and energy (discharge voltage), the X-ray diffraction patterns for the TC6 substrate also changed. The intensity of (110) in β -Ti was gradually enhanced, whereas the intensity of (101) in α -Ti decreased and the width became broader, which may be related to the plasticity and conductivity of constituent phases. The good plasticity ensured the β -Ti phase absorbing enough bombardment energy by deformation, yet its lower conductivity caused the dynamic recovery of the β -Ti phase. Thus, the β -Ti phase showed a progressively increased intensity for the (110). For the α -Ti phase with lower strength and poor ductility [53], the enhanced ion bombardment increased its dislocation density and refined its grain, leaving the X-ray diffraction patterns with broadened and smooth peaks.

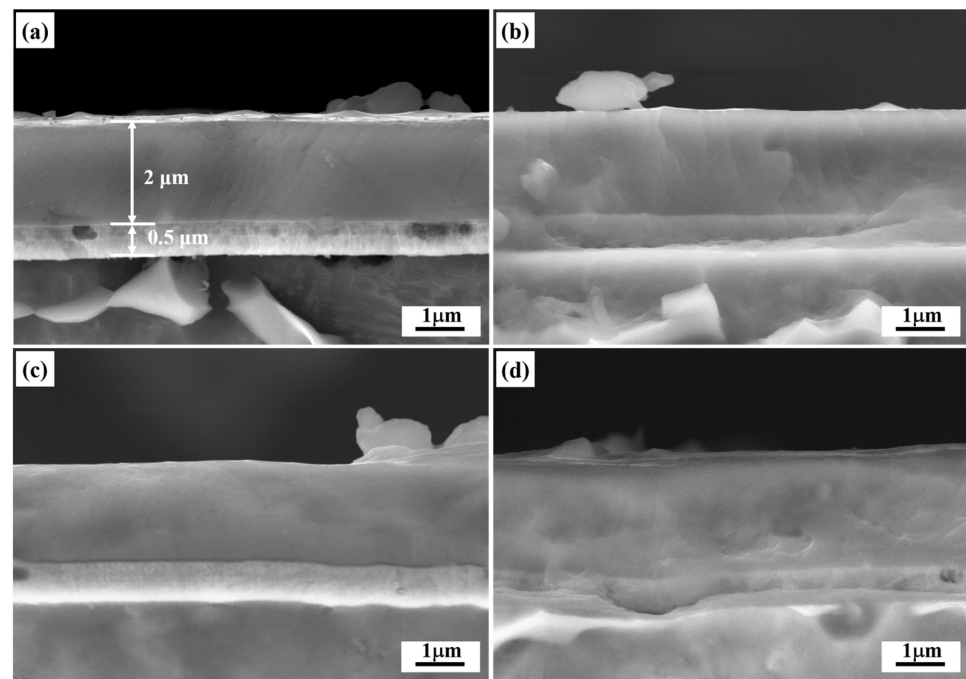
Figure 6. Cross-sectional morphology of the TiAlSiN coating with various discharge voltages: (a) -500 V, (b) -560 V, (c) -570 V, (d) -600 V.

To investigate the cross-sectional microstructure and thickness of the TiAlSiN coatings, SEM images were collected in an SE mode and are shown in Figure 6. The coating structure is distinguished by the light and dark layers. The light layer is the mixture of the Cr + CrN_x buffer layer, with a thickness of ~ 500 nm. The dark layer is the TiAlSiN coating, with a thickness of ~ 2 μ m. The overall thickness of whole coating on the TC6 substrate was measured to be ~ 2.5 μ m. All prepared TiAlSiN coatings exhibited a dense and smooth structure, almost free from columnar structure, which fit well with the nanocomposite (*nc*-TiN/*a*-SiN_x) structures in previous studies [26,55,56]. With the increase in discharge voltage, enhanced ion bombardment not only inhibited the growth of columnar formation but also refined the grains inside the TiAlSiN coating. Hence, the microstructure became denser and denser. The deposition rate was unfortunately reduced from 33 to 25 nm/min when the discharge voltage was increased from -500 to -600 V, as shown in Table 2.

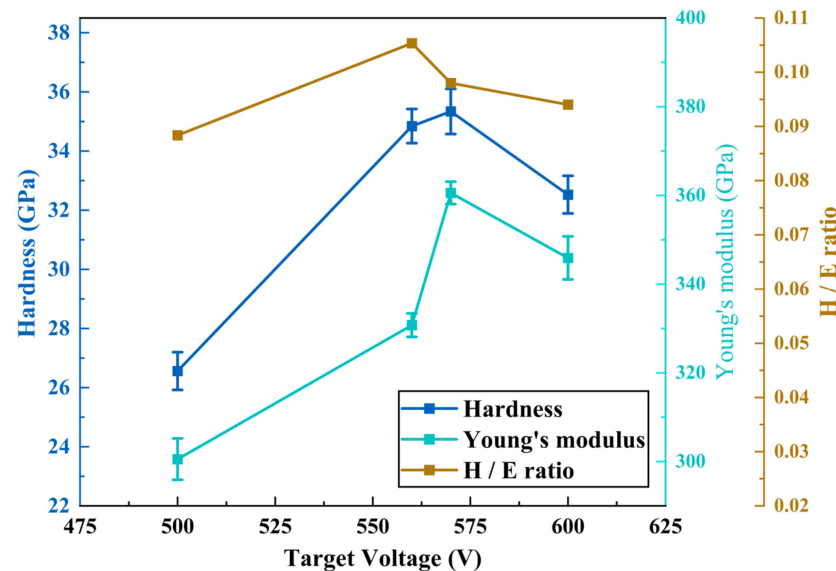
Figure 7. Hardness, Young's modulus, and H/E ratio of the TiAlSiN coatings dependent on discharge voltage.

The hardness, Young's modulus, and H/E ratio of the TiAlSiN coatings dependent on various discharge voltages were evaluated by a nanoindentation tester and are illustrated in Figure 7. It is obvious that the hardness and Young's modulus of the prepared coatings continuously increased to the maximum values of 35.34 ± 0.63 and 360.6 ± 2.5 GPa, respectively, as the discharge voltage increased to -570 V, whereas further increasing the discharge voltage to -600 V caused their values to decrease respectively. Although the mechanical properties of the prepared coatings were influenced by many factors including phase composition, microstructure, residual compressive stress, etc., they were determined by some dominant factors under certain conditions. In our cases, for the TiAlSiN-500 coating, the high fraction of amorphous structures caused the lowest hardness (28.16 ± 0.64 GPa) and Young's modulus (300.5 ± 4.6 GPa), which seemed to be consistent

with the reports in the Introduction where a high content of amorphous phases can degrade the coating coherence. With increasing the discharge voltage to 560 V, the better crystallinity and (220) plane preferred orientation of the FCC structures confirmed the hardness and Young's modulus increasing to 34.85 ± 0.58 and 330.7 ± 2.7 GPa, respectively [20,49,50]. For the TiAlSiN-570 coating, the more refined grains and introduced residual compress certified the hardness and Young's modulus arriving at their maximum values. In addition, the increment of Young's modulus between TiAlSiN-560 and TiAlSiN-570 was larger than that between TiAlSiN-500 and TiAlSiN-560. For the TiAlSiN-600 coating, the (200) preferred orientation and increased residual stress resulted in the hardness and Young's modulus reversely decreasing to 32.53 ± 0.63 and 355.9 ± 4.8 GPa, arising out of the higher Schmid factor (200) plane compared with the (220) plane [51,55].

The coating toughness was evaluated by the H/E ratio in previous studies [54,57], where the higher the H/E ratio, the stronger the suppression of crack initiation and propagation of coating. To evaluate the crack resistance of the TiAlSiN coating at various discharge voltages, the H/E ratio is also displayed in Figure 6. It indicated that with the increase in discharge voltage, the trend of the H/E ratio was the same as that of the hardness and Young's modulus, initially increasing before decreasing. The TiAlSiN coating with largest H/E ratio of 0.105 was prepared at the discharge voltage of -560 V, which means this formed network structures between *nc*-TiN and *a*-Si₃N₄ that could effectively absorb the impacting energy of erosion sand and the possibility of less destruction. This result suggested that, under the correct set of discharge voltages in the HPPMS pulse, the prepared coating may present excellent toughness.

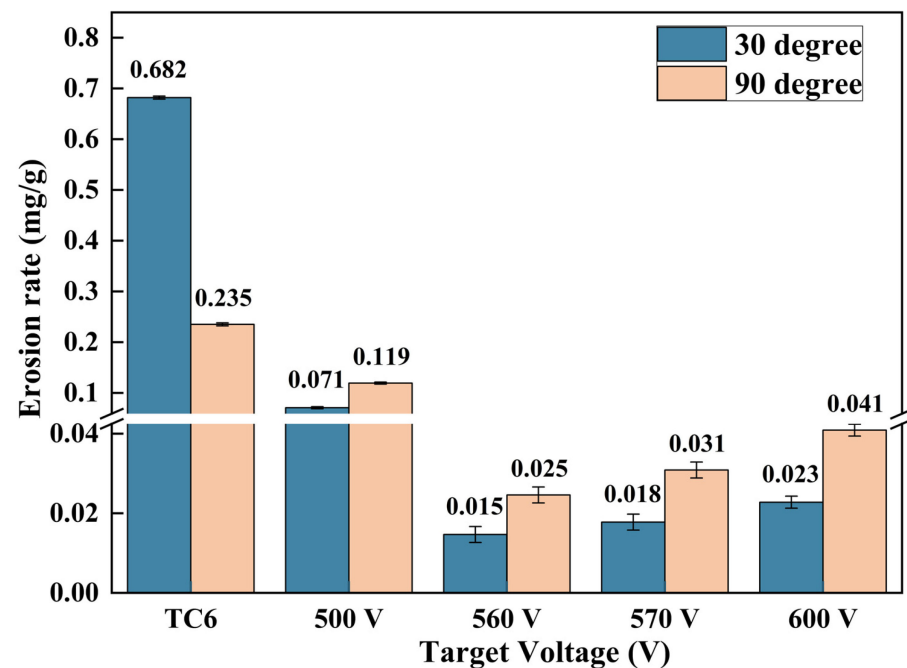
Figure 8. Erosion rates of the TC6 substrate and TiAlSiN coatings with discharge voltage.

To evaluate the erosion resistance of the TiAlSiN coatings with various discharge voltages relative to the TC6 substrate, average mass loss rates were calculated and are shown in Figure 8. Generally, the maximum erosion rate appears at low angles of incidence ($15^\circ \sim 45^\circ$) for ductile materials [58] and at a normal angle of incidence (90°) for most brittle material [59]. Hence, impingement angles of 30° and 90° for solid particle relative to sample surface were chosen for the erosion test. The TC6 titanium alloy substrate suffered more

mass loss at the impingement angle of 30° sand erosion, which corresponded to its ductile nature. The TiAlSiN coatings experienced more mass loss at the impingement angle of 90° sand erosion, confirming their brittle nature. All TiAlSiN coatings presented protection benefits for the TC6 titanium alloy. The erosion rates of the TC6 substrate were 0.682 ± 0.003 and 0.235 ± 0.002 mg/g at the impingement angles of 30° and 90° , respectively, which were about 9 and 2 times more than that of the TiAlSiN-500 coating. When increasing the discharge voltage to -560 V, the prepared TiAlSiN-560 coating displayed erosion rates with values of 0.015 ± 0.002 and 0.025 ± 0.002 mg/g at the impingement angles of 30° and 90° sand erosion, respectively, which were only 1/45 and 1/9 of the TC6 substrate. As the discharge voltage further increased to -570 and -600 V, the erosion rates rose gradually, reaching 0.023 ± 0.002 and 0.041 ± 0.002 mg/g, respectively, for the TiAlSiN-600 coating at 30° and 90° sand erosion, respectively, corresponding to 1/30 and 1/5 of the TC6 substrate. The TiAlSiN-560 coating displayed the minimum erosion rate, which meant that it possessed the best erosion resistance and can be the optimal protection for the TC6 substrate among the prepared samples. The trend of coating erosion resistance was consistent with that of the H/E ratio under various discharge voltages. It revealed that the highest H/E ratio of the hard coating can ensure its excellent erosion resistance, which was compatible with previous reports [26,60].

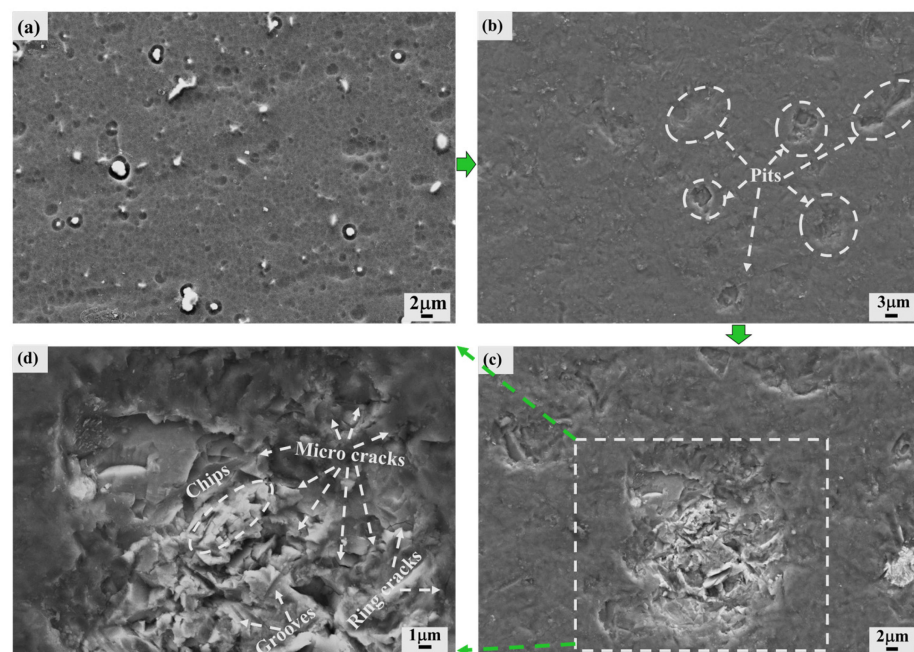
Figure 9. The damage evolution of the TiAlSiN-500 coating at 90° sand erosion, surface morphology of the (a) as-deposited coating, (b) eroded coating after ~30 s erosion, (c) erosion pit before substrate exposure, and (d) enlarged area in (c).

The erosion damage evolution and characteristics were deduced based on the morphology investigation of the TiAlSiN coatings before and after erosion damage by SEM. Figure 9 shows the damage evolution of the TiAlSiN-500 coating at 90° sand erosion. The as-deposited TiAlSiN coating presented some nodule and hole-like defects on its surface, as shown in Figure 9a, which might have come from some arcing, the change of target surface morphology, and the re-deposited insulated TiAlSiN coating on the target surface [61,62]. These defects could facilitate crack initiation during particle erosion, leading to the premature damage of the coating [63,64]. Then the amount and size of the micro pits increased on the coating surface after the early stages of erosion, as shown in Figure 9b, decreasing the coherence of coating. In the following sand erosion, these micro pits were broadened and presented a severely damaged area in the center, as displayed in Figure 9c. From the morphology of enlarged area in its center, as indicated in Figure 9d, numerous micro cracks and chips can be observed, and somewhat ringed cracks are present around the edge of eroded pit. These cracks were caused by the tensile stress formed during particle

impingement [65]. As erosion proceeded, these cracks may have propagated and coalesced, resulting in coating failure and substrate exposure.

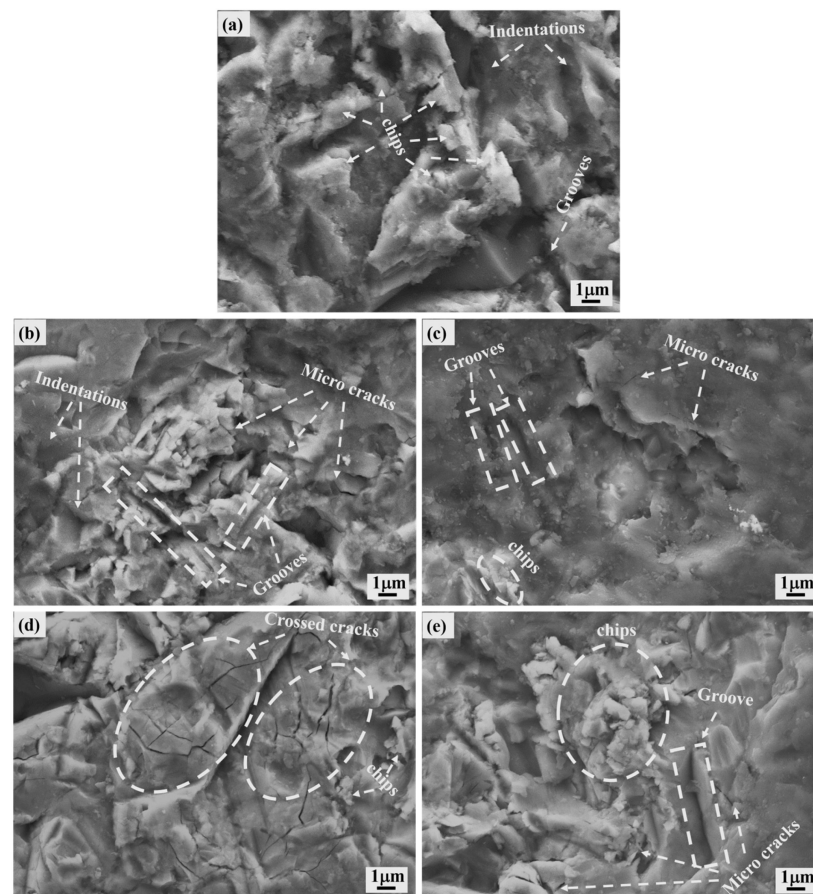
Figure 10. The surface morphology of the center part in the erosion pit for the (a) TC6 substrate, (b) TiAlSiN-500, (c) TiAlSiN-560, (d) TiAlSiN-570, (e) TiAlSiN-600 at 90° sand erosion.

To evaluate the failure mechanism and damage degree of the TiAlSiN coatings dependent on discharge voltage at 90° sand erosion, high-magnification morphologies of the center part in the erosion pit were collected and are shown in Figure 10. For the TC6 substrate, we can clearly note deep indentations and lots of chips on their sides, as displayed in Figure 9a. Because of the high ductility of the TC6 substrate, the material was easily

indented and the indentations were deep with the emergence of extruded lips. Most of these lips were forged into chips by the repeated impacting of solid particles, resulting in the substrate material removal. This indicated that the dominant material removal of the mechanism at 90° sand erosion was the material plastic deformation and work hardening during the repeated impacts of the solid particles [66]. In comparison, the eroded coatings presented shallower indentations, finer fragmentary chips, and more micro cracks, which were the brittle fracture characteristics of the ceramic hard coating [67].

However, the extent of the damage to coatings significantly depended on the prepared samples. The TiAlSiN-560 coating showed the least erosion damage, with much smaller numbers of chips and micro cracks and a relatively smooth surface shown in Figure 10c, whereas the TiAlSiN-500 coating displayed the serious destruction shown in Figure 10b. The main reason traces back to the difference in their crystallinity. The TiAlSiN-560 coating with good crystallization and (220) preferred orientation presented higher hardness and excellent toughness, which were beneficial for its lowest erosion rate among the coatings, as shown in Figure 7. Moreover, based on the smooth surface of its eroded pit, the erosion damage of the TiAlSiN-560 coating may be mainly in the form of layer by layer, for its high hardness ensured the excellent resistance of the coating to erosion damage, and its excellent toughness could assure the coating had a strong ability to absorb impact energy and inhibit initiation of cracks in the sublayer. When the discharge voltage increased to -570 V, the prepared sample displayed serious destruction again after the sand erosion, with a large number of chips and micro cracks, particularly the emerged crossed cracks with reticular distribution, yet with a smooth surface (Figure 10d). Although this TiAlSiN-570 coating with (220) preferred orientation, refined grain, and compressive stress had

the highest hardness and dense structure, its erosion resistance was lower than that of the TiAlSiN-560 coating. This can be attributed to its decreased toughness (H/E ratio) shown in Figure 6. It seems that the toughness instead of the hardness contributed more in determining the erosion resistance of the brittle coatings under 90° sand erosion. While further increasing the discharge voltage to −600 V, the prepared coating not only exhibited an increase in the number of chips but also became rougher, as shown in Figure 10e, after erosion damage, indicating enhancement in the severity of brittle fracture. It revealed that despite densifying the coating structure by the enhanced ion bombardment, the increased residual stress and (200) preferred orientation led to this TiAlSiN-600 coating having lower mechanical properties and erosion resistance. Another point that should be noticed is that all of these samples displayed somewhat ductile erosion failure characteristics such as grooves [68]. Owing to the irregular shape of the Al₂O₃ solid particle, the sharp corners of some particles may be at an acute angle to the coating surface and the microcutting mechanism of material removal occurred, resulting in the appearance of grooves. In addition, the expansion of particle carrier gas at the outlet of the nozzle led to some Al₂O₃ solid particles deviating from the trajectory of perpendicular impingement, also increasing the probability of the presence of grooves.

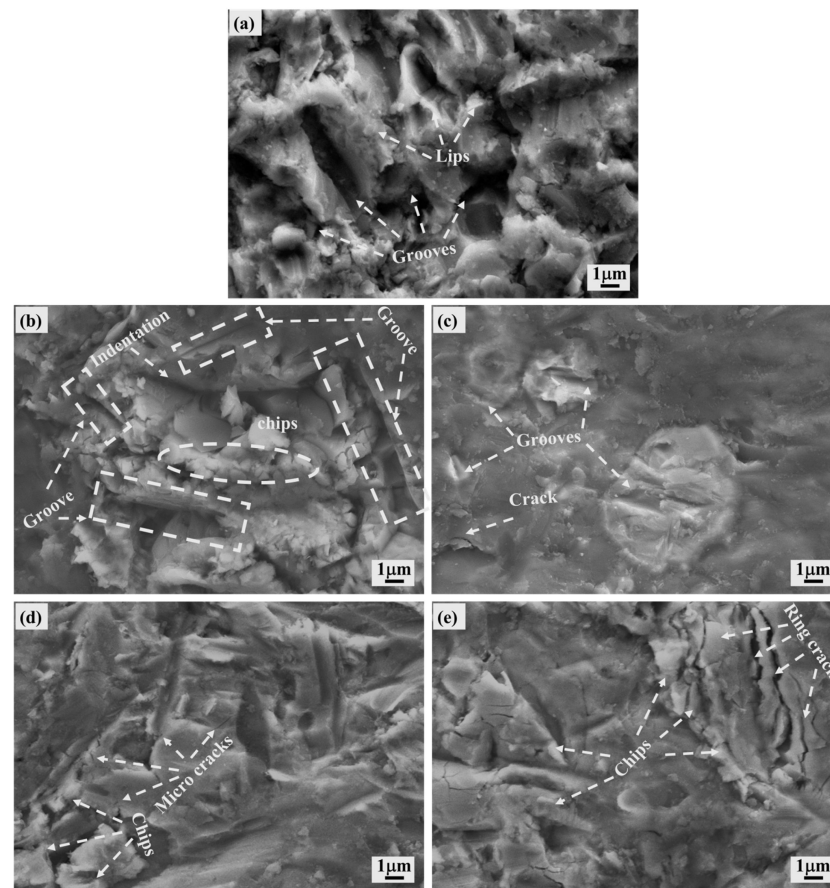
Figure 11. The surface morphology of the center part in the erosion pit for the (a) TC6 substrate, (b) TiAlSiN-500, (c) TiAlSiN-560, (d) TiAlSiN-570, (e) TiAlSiN-600 at 30° sand erosion.

At 30° sand erosion, the erosion behavior variations of the TiAlSiN coatings with various discharge voltages were also analyzed with respect to that of the TC6 substrate, as shown in Figure 10. The energy of the inclined impacting particles can be decomposed into two mutually orthogonal forces, which are a force parallel to the surface and another normal to the surface. The parallel component can result in material microcutting damage, whereas the vertical component can lead to chipping damage. At 30° sand erosion, owing to the larger parallel component of the particle impact force, microcutting was often regarded as the major mechanism for material removal based on the material being isotropic. For the ductile isotropic TC6 substrate as an example, we can notice that the microcutting caused the eroded surface to present large numbers of deep grooves with raised lips (Figure 11a), which fit well with the typical failure features reported by Finnie [68]. After the TiAlSiN ceramic hard coating deposited on the TC6 substrate, because of its high hardness with some chipping resistance, the four samples presented shallower plowing grooves compared with the TC6 substrate. The grooves displayed different characteristics arising from the microstructure and mechanical property changes in the prepared coatings. Among these four coating samples, the TiAlSiN-500 coating presented the deepest grooves with largest number of chips rather than the lips (Figure 10b), revealing that it underwent not only serious microcutting, but also chipping disruption, which was consistent with its lowest hardness and toughness, indicated in Figure 7, and weakest erosion resistance in Figure 8. Whereas the TiAlSiN-560 coating exhibited the shallowest grooves without chips and sporadic cracks (Figure 11c), verifying its strongest erosion resistance. The shallowest grooves may be attributed to the (220) preferred orientation, for it has a lower Schmid factor [51,55], which can make it hard for the coating to slide under the microcutting damage. The lack of chips and sporadic cracks may benefit from the highest toughness, for it can ensure the compatible deformation of the coating under microcutting and chipping damage. For the TiAlSiN-570 coating, although the grooves rendered a similar depth as that on the TiAlSiN-560 coating, the appearance of more micro cracks and some chips around the grooves indicated the more brittle nature of the coating (lower H/E ratio in Figure 7), leading to the degradation of erosion resistance (Figure 8). With the discharge voltage further increased to −600 V, surrounding the shallow grooves were quantities of ring cracks in addition to micro cracks and chips, demonstrating that the coating underwent more serious microcutting and chipping brittle erosion behavior and had a lower erosion rate. This may have resulted from the (200) orientation with a higher Schmid factor [51,55], which led the coating to slide easily under the microcutting damage. The poor toughness caused serious chipping damage.
