phys. stat. sol. (a) **169**, 49 (1998)

Failure Mechanisms of a SiC Particles/2024Al Composite under Dynamic Loading

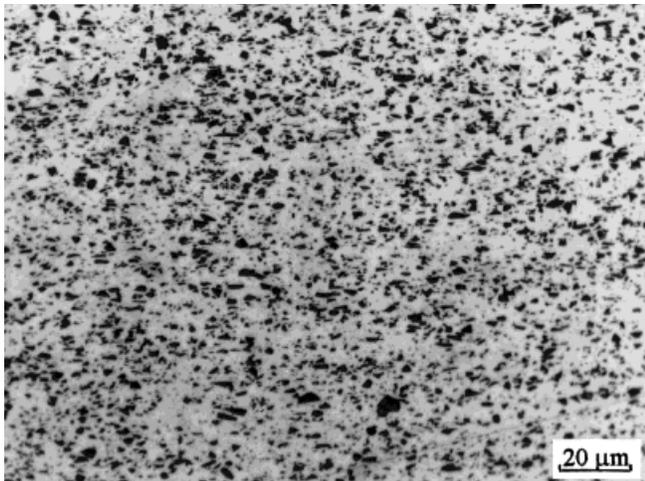
Fig. 1. Optical micrograph of the as-prepared 20 vol% 3.5 μm SiCp/2024Al composite

The SiCp/2024Al composite used in the present paper was fabricated by a powder metallurgy process using 2024Al powder of 280 grits and SiC particles with an average grain size of 3.5 μm . The mixed powder with a SiC volume fraction of 20% was compacted by hot compression under vacuum. The compacted powder was then extruded at 450 $^{\circ}\text{C}$ to rods of 1.2 cm diameter with an extrusion ratio of 40:1. The composite was then solution treated at 500 $^{\circ}\text{C}$ for 1 h followed by water quenching and subsequently ageing at 170 $^{\circ}\text{C}$ for a duration of 6 h (T6 treatment). The microstructure of the as-prepared composite is shown in Fig. 1, which indicates that SiC particles are evenly distributed and there is no observable defect. Tensile samples of 0.32 cm diameter \times 1 cm gauge length and compression samples of 0.8 cm diameter \times 0.6 cm height

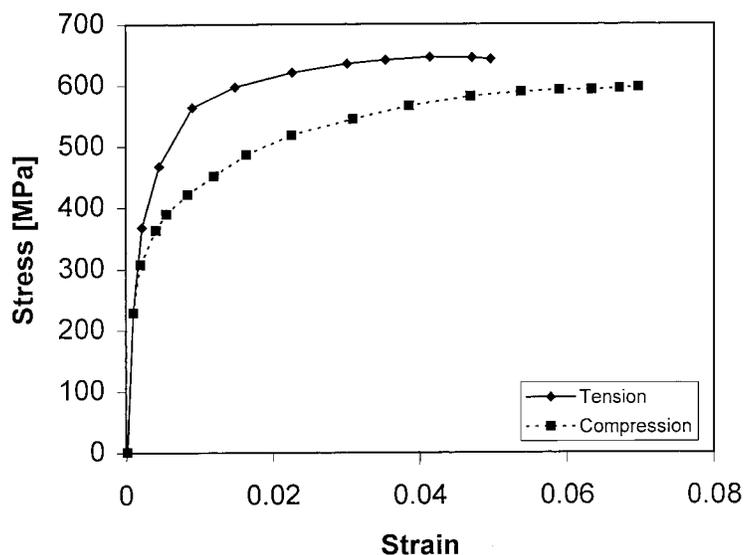
Fig. 2. Stress–strain response of the composite at a strain rate of 10^3 s^{-1}

Dynamic stress–strain curves of the composite tested in tension and in compression at a strain rate of 10^3 s^{-1} are shown in Fig. 2. Work hardening can be observed in the initial stage of the plastic deformation. The flow stresses reach their saturation values after about 5% strain. The tensile flow stress is higher than the compressive flow stress at all strains. This asymmetry of the tensile and compressive strength is due to the internal residual stresses, originating in the difference in thermal expansion coefficient of the matrix and SiC particles, generated during the production process of the composite [13].

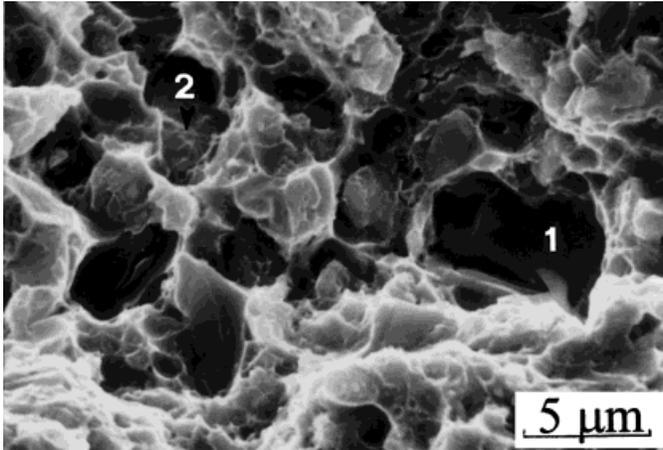
Fig. 3. Tensile fracture surface of the SiCp/2024Al composite

The tensile fracture surface shows features of brittle fracture at a relatively macroscopic scale (Fig. 3). However, in a microscopic view, dimples showing ductile shearing can also be seen. Dimples observed are of two different size ranges. The large and the small dimples have sizes similar to those of the SiC particles and precipitated phases (about $1 \text{ }\mu\text{m}$ size), respectively. SiC particles found on the fracture surface are of two different types of feature. The first type shows a smooth and flat fracture surface along the cleavage planes of SiC. As SiC has several low index cleavage planes, the fracture

of SiC particles can proceed with cleavage along several planes simultaneously and gives rise to secondary cracks (marker 1 in Fig. 3). Some SiC particles on the fracture surface show a ductile tearing failure along the SiC–Al interface. This type of failure is different from the commonly observed interfacial debonding which would give rise to a much smoother fracture surface. Marker 2 in Fig. 3 shows a SiC particle adhering with ridges originated from tearing of the aluminium matrix. This was also verified by EDX analysis which showed that the aluminium content at marker 2 is much higher than that

TEM observations of the dynamically loaded samples show that various forms of defects were accumulated in the SiC particles. In addition to stacking faults, locations with high stress concentration, such as sharp corners of the SiC particles, were often fractured (Fig. 5). The dislocation density increased tremendously in both the interface and the matrix regions. Fracture of SiC was also observed with the cracks usually initiated from locations of high stress concentrations such as stacking faults or corners of the SiC particles (Fig. 6). Tearing failure found in the fracture surface (Fig. 3) and adhe-

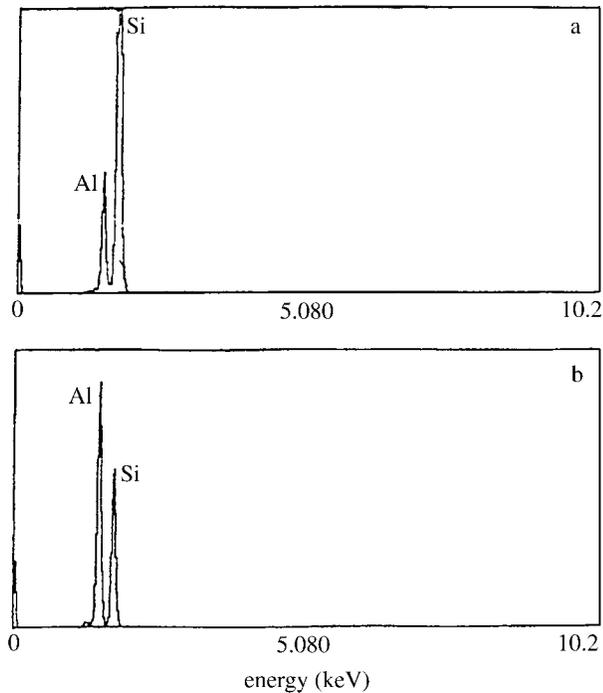
Fig. 4. EDX spectra taken at a) marker 1 and b) marker 2 of the sample as shown in Fig. 3

at marker 1 (Fig. 4). This tearing failure near the SiCp/Al interface is similar to the corresponding observation in SiC whisker-reinforced Al composite [17]. However, to the authors' knowledge, it has not been reported in SiC particles reinforced aluminium composites. The tearing failure indicates that the composite used here has a high SiC–Al interfacial bonding strength.

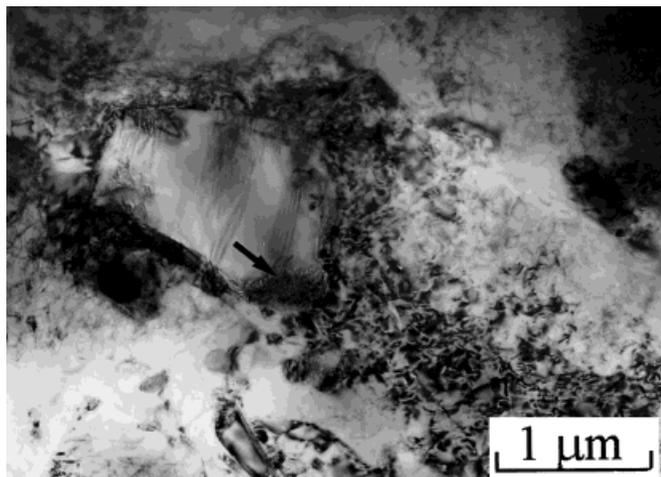
Fig. 5. A TEM micrograph of the SiCp/2024Al composite after dynamic loading showing damages in the microstructure

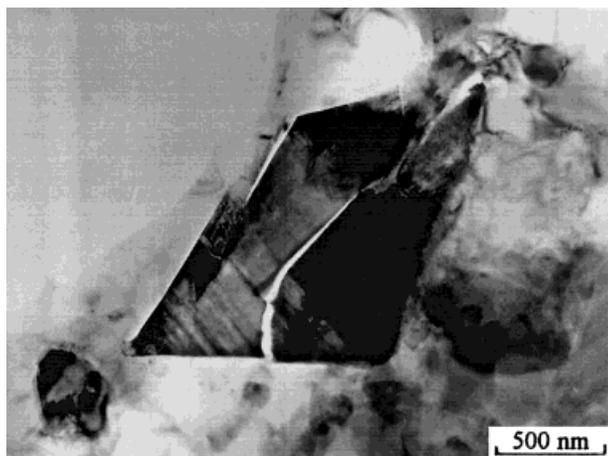
Fig. 6. A TEM micrograph showing cracking of a SiC particle after dynamic loading

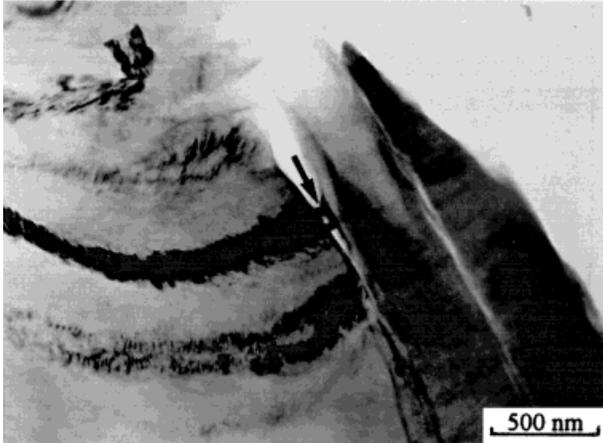
Fig. 7. A TEM micrograph showing tearing of an Al-SiC interface

sion of aluminium to the SiC particle (indicated by an arrow) can also be observed in Fig. 7.

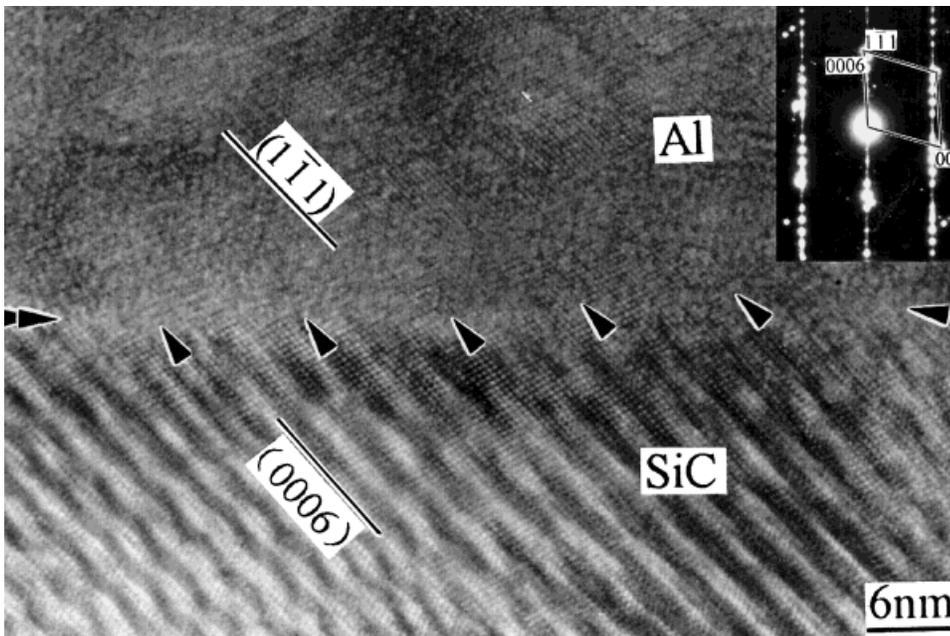
Fig. 8. A high-resolution TEM micrograph showing a coincident site lattice relationship in an Al-SiC interface. Selected area electron diffraction pattern from the interface is shown in the inset

High-resolution TEM studies of the SiC-Al interface show that many of the SiC particles have coincident lattice sites with the matrix along the interface. Fig. 8 shows one of these interfaces (marked by double arrows), where the orientation relationship $[110]_{\text{Al}} \parallel [\bar{2}110]_{\text{SiC}}$, $(1\bar{1}1)_{\text{Al}} \parallel (0006)_{\text{SiC}}$ was observed (there is a small angle, about 2° , between the Al $(1\bar{1}1)$ and the SiC (0006) planes). It can be seen that the interface is

smooth with some mismatch dislocations (marked by single arrows) due to the different spacings of the Al ($\bar{1}11$) and the SiC (0006) planes (0.234 and 0.251 nm, respectively). The high interfacial bonding strength in the present composite can be attributed to these interfaces with coincident site lattice. More systematic high-resolution TEM work on this issue is under way to fully characterize the interfaces in the present composite.
