Article Study on the Influence of Defects on Fracture Mechanical Behavior of Cu/SAC305/Cu Solder Joint

Abstract: The fracture behavior of the Cu/Sn-3.0Ag-0.5Sn (SAC305)/Cu solder joint was investigated by conducting tensile tests with in situ X-ray micro-computed tomography (μ -CT) observation, and finite element (FE) simulation. The tensile fracture process of solder joints with a real internal defect structure was simulated and compared with the experimental results in terms of defect distribution and fracture path. Additionally, the stress distribution around the defects during the tensile process was calculated. The experimental results revealed that the pores near the intermetallic compound (IMC) layers and the flaky cracks inside the solder significantly affected the crack path. The aggregation degree of the spherical pores and the angle between the crack surface and the loading direction controlled the initiation position and propagation path of the cracks. The fracture morphology indicated that the fracture of the IMC layer was brittle, while the solder fracture exhibited ductile tearing. There were significant differences in the fracture morphology under tensile and shear

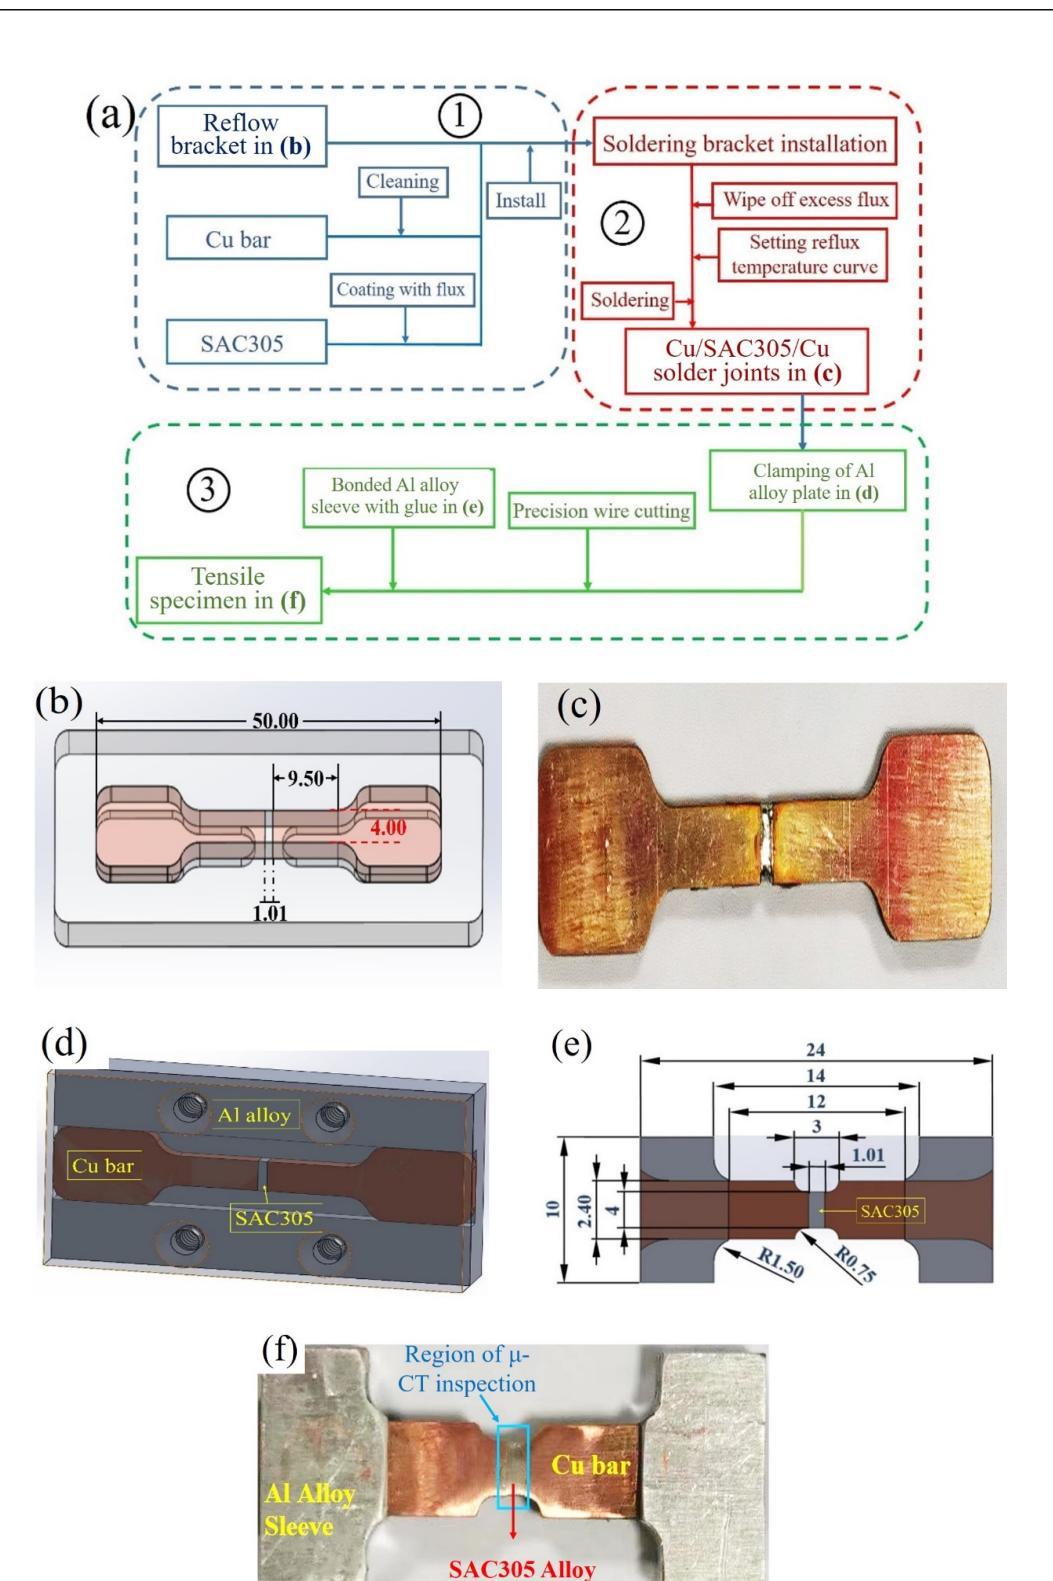
Figure 1. (a) The flow diagram of tensile specimen preparation (①: Materials preparation for soldering;②: soldering process;③: tensile specimen processing); (b) reflow bracket; (c) Cu/SAC305/Cu solder joint; (d) self-designed clamp of Al alloy; (e) specimen size and geometry in this experiment (unit: mm); (f) in situ uniaxial tensile specimen.

The solder used in the experiment was the commercial SAC305 alloy, its nominal composition was displayed in Table 1. To investigate the tensile fracture properties of Cu/SAC305/Cu solder joints, the flow diagram of tensile specimen preparation was shown in Figure 1a, which mainly included three steps. Firstly, two 99.9% Cu bars with a surface roughness, $Ra = 1.6 \mu m$, and SAC305 alloy were installed in the specific reflow soldering bracket, which was designed as shown in Figure 1b. The thickness of the substrate was 2.00 mm, the width of its middle position was 4.00 mm and the length was 50.00 mm. The surface of the Cu bar was cleaned before soldering. The cleaning method was to put the Cu bars into solution for cleaning PCB (QL-C7006, ZHEJIANG QLG, Wenzhou, China), and perform ultrasonic oscillation for 8 s. The SAC305 solders and the two bars were coated with flux on both sides, and the excess flux was wiped off. Secondly, according to the requirements of the industrial lead-free soldering reflow temperature curve, the soldering bracket was put into a commercial reflow oven (HERLLER 1809-MK3, HELLER INDUSTRIES, Florham Park, NJ, USA) with a soldering temperature of 265 °C [38]. After soldering, the solder joint was polished using SiC sandpaper with grit scales of 800 and 3000, respectively. The harvested specimens are shown in Figure 1c. The transverse area of the solder joints was $4.00 \times 2.02 \text{ mm}^2$, and the thickness was approximately 1.01 mm.

Finally, to satisfy the size requirements of the tensile setup and X-ray image, the uniaxial tensile specimen was designed in a dog-bone shape. During the manufacturing process, the solder alloy and the Cu bars were fixed by the self-designed clamp of the Al alloy, as shown in Figure 1d. Precision wire cutting was used, and the geometric dimensions of the tensile specimen were in Figure 1e. To prevent the specimen from pulling off from the grips of the tensile machine, the clamping end of the specimen was wrapped by an Al alloy sleeve, and the clamping end and Al alloy sleeve were bonded with the glue, as shown in Figure 1e. Finally, the uniaxial tensile specimen was obtained, as shown in Figure 1f.

inspection area was indicated by the blue rectangle in Figure 1e. The scanning parameters of the X-ray μ -CT were optimized by considering the quality of the scanning images and the unloading effect caused by suspending the experiment. During the test, the voltage and current were 150 kV and 67 μ A, respectively. The size of the X-ray raw tomography images was 2048×2048 pixels. To obtain a clear image of the internal structure of the pores, the specimen was scanned at 180°, and 501 images were obtained in total. Therefore, the resolution of obtained image was 5.46 μ m/pixel. The exposure time of each projection image was approximately 10 s, and the process lasted for approximately 2.5 h. The defect distribution of the Cu/SAC305/Cu solder joint was reconstructed using the VG studio software, as shown in the Figure 2. The different colors of the defects in the Figure 2 indicated the volume of each defect. The geometric shapes of defects were mainly divided into spherical shape and flat shape, which were called spherical pores and flakes, respectively. The spherical pores were mainly distributed in the upper and lower layers of solder joint, namely IMC layers; flakes were mainly distributed inside the solder. The formation mechanism of defects with two different shapes would be explained in detail in Section 4.1.

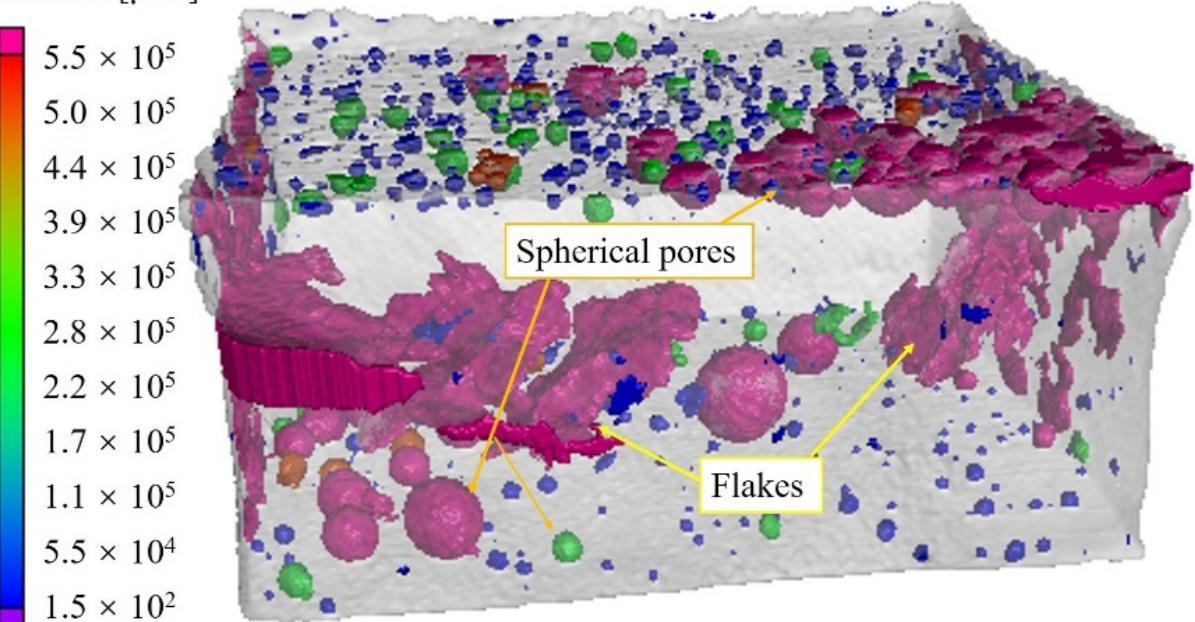
Figure 2. Reconstructed structure of defects in the Cu/SAC305/Cu solder joints.

Defects were inevitable for solder joints [11]. As shown in Figure 2, there were many spherical pores in the upper and lower boundaries (the IMC layer and its vicinity) of the reconstructed solder joints, and most of these pores were mutually separated. Generally, it was considered that the main causes of the internal defects of solder joints are as follows: (1) the additive or organic impurities remaining in the Cu bar; (2) the poor wettability of the solder; and (3) the exhaust of the solder and flux during reflow [18,44]. In this study, after the surface of the Cu bars was cleaned by solution for cleaning PCB, a small amount of water and organic material remained on its surface. In addition, the flux was a volatile material [10]. Therefore, during the reflow soldering process, a high temperature caused the flux, remaining water, and organic material to evaporate, and then left the molten solder alloy. However, some gases were not discharged, which resulted in some gases remaining in the solder joints to form spherical pores. Many pores were concentrated near the IMCs. Moreover, there were a few pores that did not completely leave the solder. The shrinkage pores and flakes might form near the solder surface after the solder solidifies, similar to the crack in the Q1 region in Figure 7a [10].

The position and shape of defects in the solder joints had a significant influence on the stress distribution. As shown in Figure 2, the pore distribution of the Cu/SAC305/Cu solder joint was very complex. However, only a few very small spherical pores and two flakes existed inside the solder. The flake in region Q1 was perpendicular to the loading axis, while the flake in region Q2 was inside the solder and approximately parallel to the loading direction. Figure 12a showed the stress distribution around the two flake cracks. Obviously, the stress concentration in region Q1 was greater than that in region Q2. Moreover, when the crack tip stress of the flake crack in region Q1 reached the fracture strength, the crack tip in region Q2 did not; therefore, the cracks did not begin to propagate. However, the aggregated pores in region Q2 around the IMC layer cracked during loading. During the subsequent propagation process, the propagation rate was significantly higher than that of the flaky crack in region Q1. To explain this phenomenon, the stress distribution in region Q2 was shown in Figure 12b. Hence, it could be inferred that the effective bearing area was greatly reduced owing to the distribution of the aggregated pores along the IMC layer. Therefore, the aggregated pores in region Q2 connected as the strain increased, which led to the cracking along the IMC layer in region Q2. Additionally, aggregated pores also existed in the lower IMC layer, as shown in Figure 2. By comparing the characteristics of the pores in regions Q2 and Q3, it was found that the average spacing of pores in region Q3 was larger. Therefore, the crack did not initiate from region Q3 of the lower IMC layer. However, in the tensile process, the separated pores constantly grew and connected inside. When the two propagating cracks in regions Q1 and Q2 connected, the aggregated pores in region Q3 also broke. As the two Q2 and Q3 fracture zones were not in the same cross-section, the S4 shear fracture region was formed. Therefore, it was understood that the fracture path of the solder joints was controlled by the shape and distribution of defects.

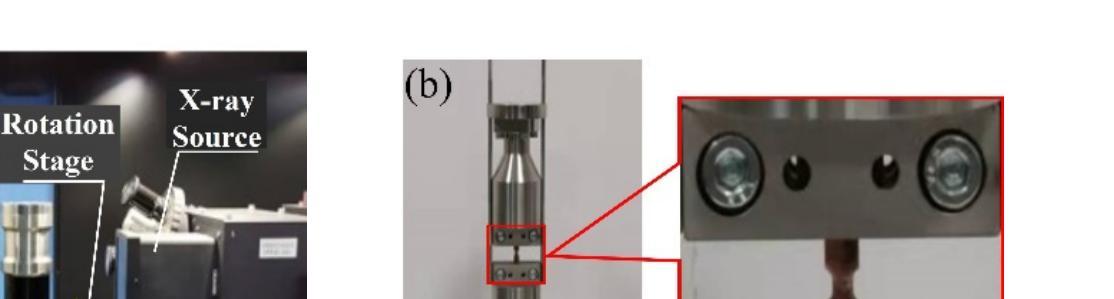
Figure 3. (a) Setup of in situ X-ray μ -CT; (b) tensile setup capable of rotating with μ -CT test piece table.

To observe the evolution of the internal defects during the tensile process, a CT5000 Deben (Judges Scientific PLC, London, UK) tensile setup was placed in the X-ray μ -CT scanning environment cavity, which was installed on the CT rotatable test table, as shown in Figure 3a. Therefore, the experimental test pieces could rotate by 360°, as shown in Figure 3b, which satisfies the scanning requirements of sample structure reconstruction by the μ -CT. The experiment was carried out in an atmospheric environment. In this experiment, the displacement loading mode was selected, and the loading rate was 0.03 mm/min. When the test piece was in the pre-load state and the displacement was 0.0279 mm and 0.1359 mm, the experiment was suspended and the X-ray μ -CT process began to work, respectively. The load and displacement of the test piece were recorded by the in situ testing machine.

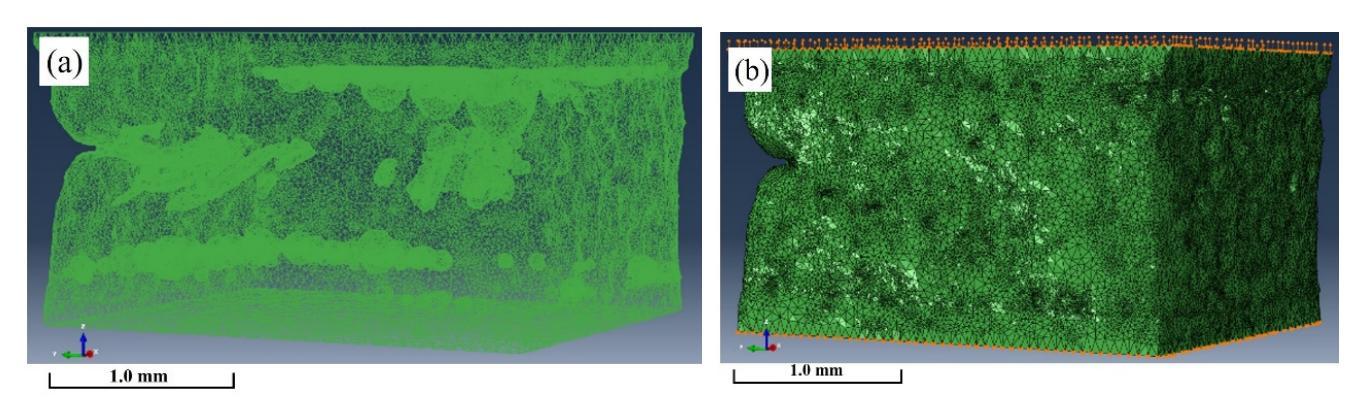
Figure 4. (**a**) Three-dimensional FE mesh model considering real internal defects; (**b**) boundary conditions and displacement loading of FE model.

A FE model with real internal defects was established to simulate the tensile fracture process of solder joints. First, the CT scanning data of the solder joint were imported into the Avizo software to generate the internal structure model. Considering that larger defects and defects near the boundary greatly influence the fracture of the material, in the FE modeling process, the defects with a volume larger than $3.00 \times 10^5 \,\mu\text{m}^3$ were retained. The obtained FE mesh model is shown in Figure 4a. The model was divided into volumetric tetrahedral meshes, and 449,168 elements were generated in total. Finally, the meshes were imported into the FE software for model pre-processing, model calculation, and post-processing analysis. In the process of uniaxial tensile testing, the lower surface of the model was completely fixed, the upper surface was set to displacement loading, and the displacement in the Z direction was set to 0.20 mm, as shown in Figure 4b. This study focused on the influence of internal defects on the fracture behavior of solder joints; therefore, the Cu bars, IMC layers, and microstructure were not considered in the modeling process.

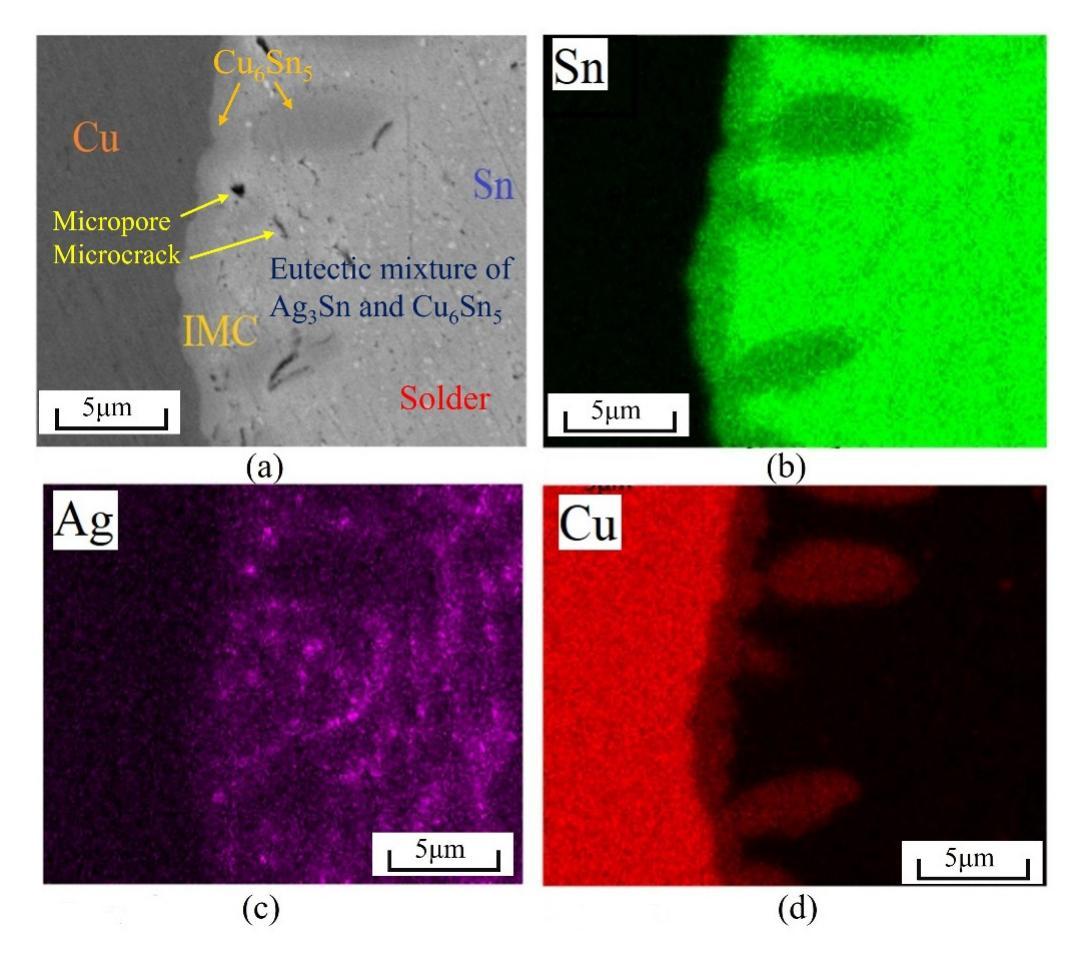
Figure 5. Microstructure and EDS mapping of surface of SAC305/Cu interfaces after polishing. (a) initial microstructure; (b) Sn element; (c) Ag element; (d) Cu element.

The main matrix of solder SAC305 was the β -Sn phase, and a large amount of the eutectic mixture of Ag₃Sn and Cu₆Sn₅ was dispersed in it [40]. After the reflow soldering process, the Cu bars at both ends had a metallurgical reaction with solder SAC305. The Cu element in the Cu bars diffused to one side of the solder, and thus formed an IMC layer [2]. Figure 5 shows the microstructure of the solder joint and the EDS mapping of the different elements. The EDS analysis revealed that the scallop-IMC layer was formed along the interface, which was mainly in the Cu₆Sn₅ phase. As the solder joint was not subjected to age treatment in this experiment, the Cu₃Sn phase did not form a thick-layered structure in the SAC305/Cu interface, similar to the Cu₆Sn₅ phase [11]. Additionally, various micropores and microcracks appeared in the IMC layer and its vicinity; their influence on the welding strength is explained in detail in Section 4.1. On the right side of Figure 5a, many Ag-rich white particles can be observed in the solder matrix. The white particles represent the Ag₃Sn phase, which indicates brittleness [1].

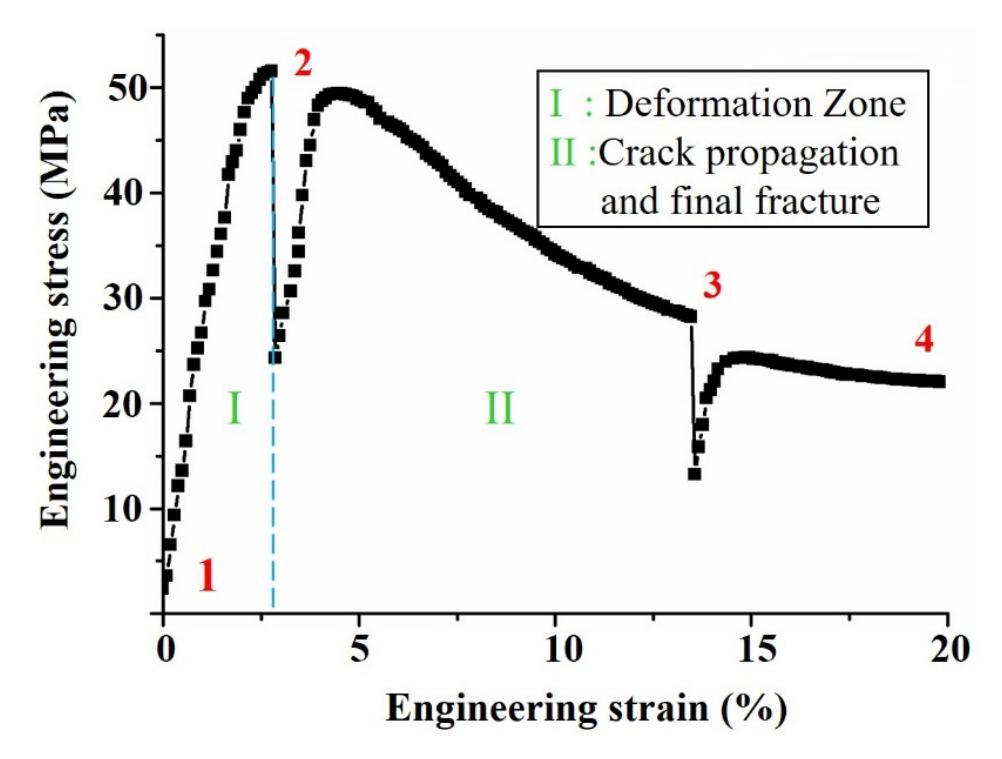
Figure 6. Engineering stress–strain curve of Cu/SAC305/Cu solder joint obtained by in situ tensile test. Positions 1, 2 and 3 represented the suspending points, and 4 represented the fracture point.

Figure 6 showed the engineering stress–strain curve of the Cu/SAC305/Cu solder joint, which was obtained from the load–displacement data of the testing machine. As could be seen from the curve, the fracture strength of the solder joint was 51.52 MPa, which was very close to the tensile strength of 55.00 MPa of the SAC305 alloy [41]. In this experiment, the gap size of the two Cu bars was 1.01 mm. Zimrich et al. [42] reported that, as the solder gap increased, the fracture strength of the solder joint gradually approached the tensile strength of the solder. Additionally, as could be seen from the curve in Figure 6, the tensile process of the solder joints could be divided into the deformation zone (I) and the crack propagation and final fracture zone (II). For both zones, the internal deformation of the material was discussed in Section 3.3. Moreover, the fracture strain of the solder joint reached 19.87%, which was mainly related to the good toughness of the SAC305 alloy [43].

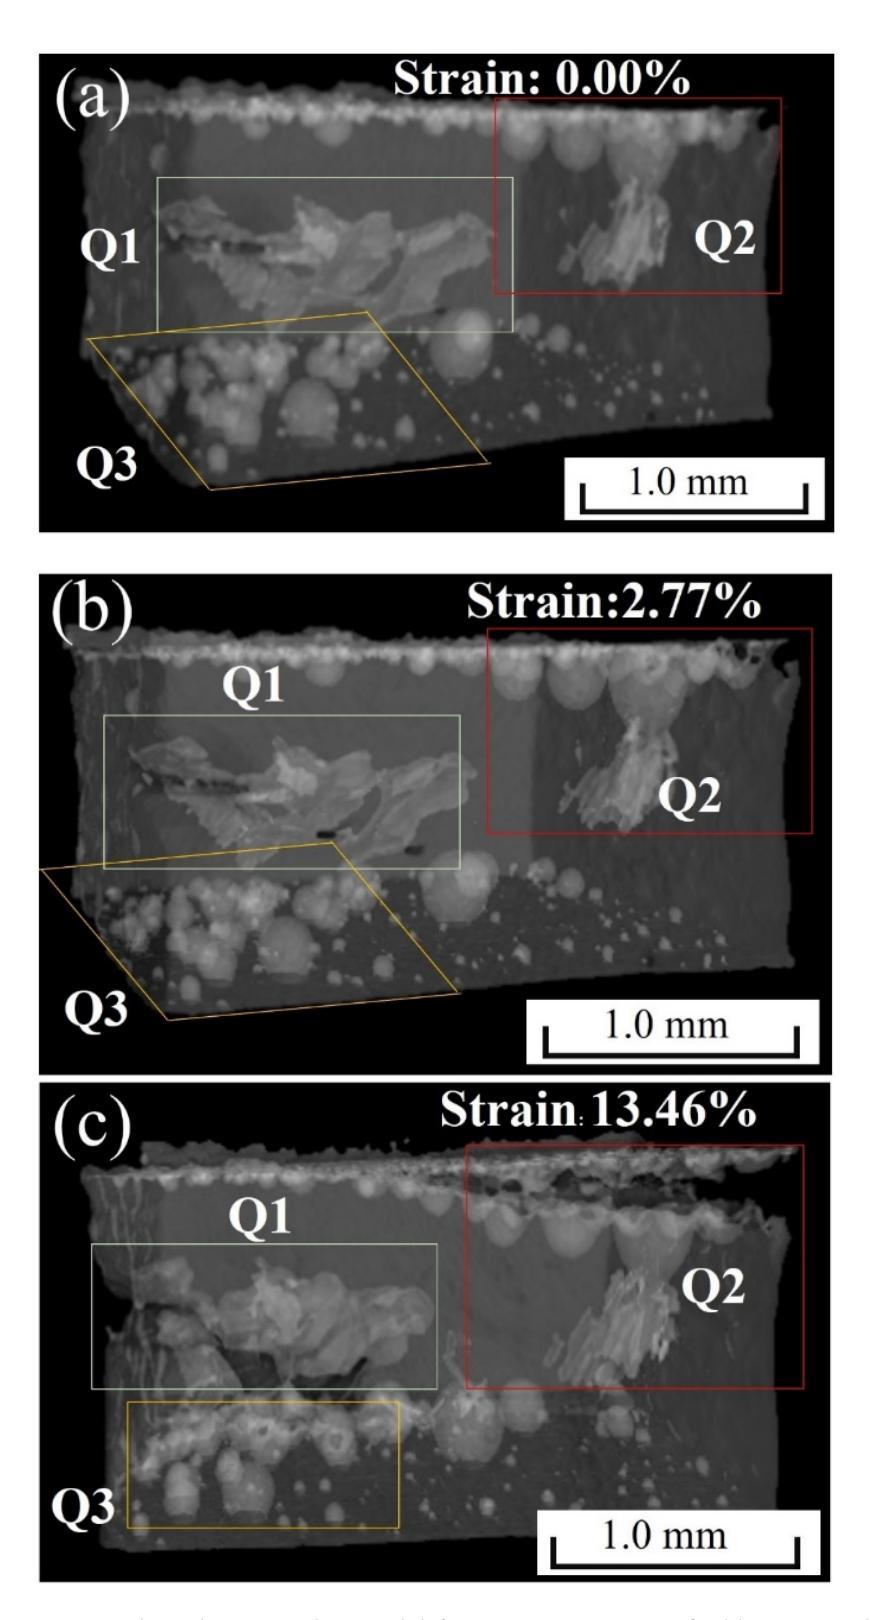
Figure 7. Three-dimensional internal defects in microstructure of solder joints at the strain of: (**a**) 0.00; (**b**) 2.77%; (**c**) 13.46%.

Figure 7 showed the 3D defect evolution of the solder joints during the tensile process at room temperature. The upper and lower boundary layers were the IMC layers connected to the Cu bars. The microstructure of the internal defects at the initial state was shown in Figure 7a. As could be seen, a flake defect existed in the middle Q1 region. Moreover, many pores were produced in the Q2 and Q3 regions near the IMC layer. The formation mechanism of the two types of defects was explained in detail in Section 4.1. The spherical pores in the Q2 region were connected at the upper IMC. When the deformation reached 2.77%, the flakes at the Q1 region opened and propagated forward. A spherical defect in the upper right corner of the Q2 region. When the strain was 13.46%, the defects in the Q1 region penetrated longitudinally and connected with various spherical pores in the Q3 region. The defects in the Q2 region formed cracks, which propagated forward along the IMC layer to the middle of the solder joint. Under continuous tension, the solder joint finally broke.

tensile fracture occurred in the Q1, Q2, and Q3 regions in Figure 7, and the fracture surface was perpendicular to the loading axis. They corresponded to the Q1, Q2, and Q3 regions in Figure 8b,c, respectively. However, since the fracture surfaces of Q1–Q3 in Figure 7 were not on the same plane, the S4 fracture surface was formed due to the shear action. Under the action of the shear force, the defects in this region underwent severe deformation. Obviously, there were significant differences between the tensile fracture and shear fracture.

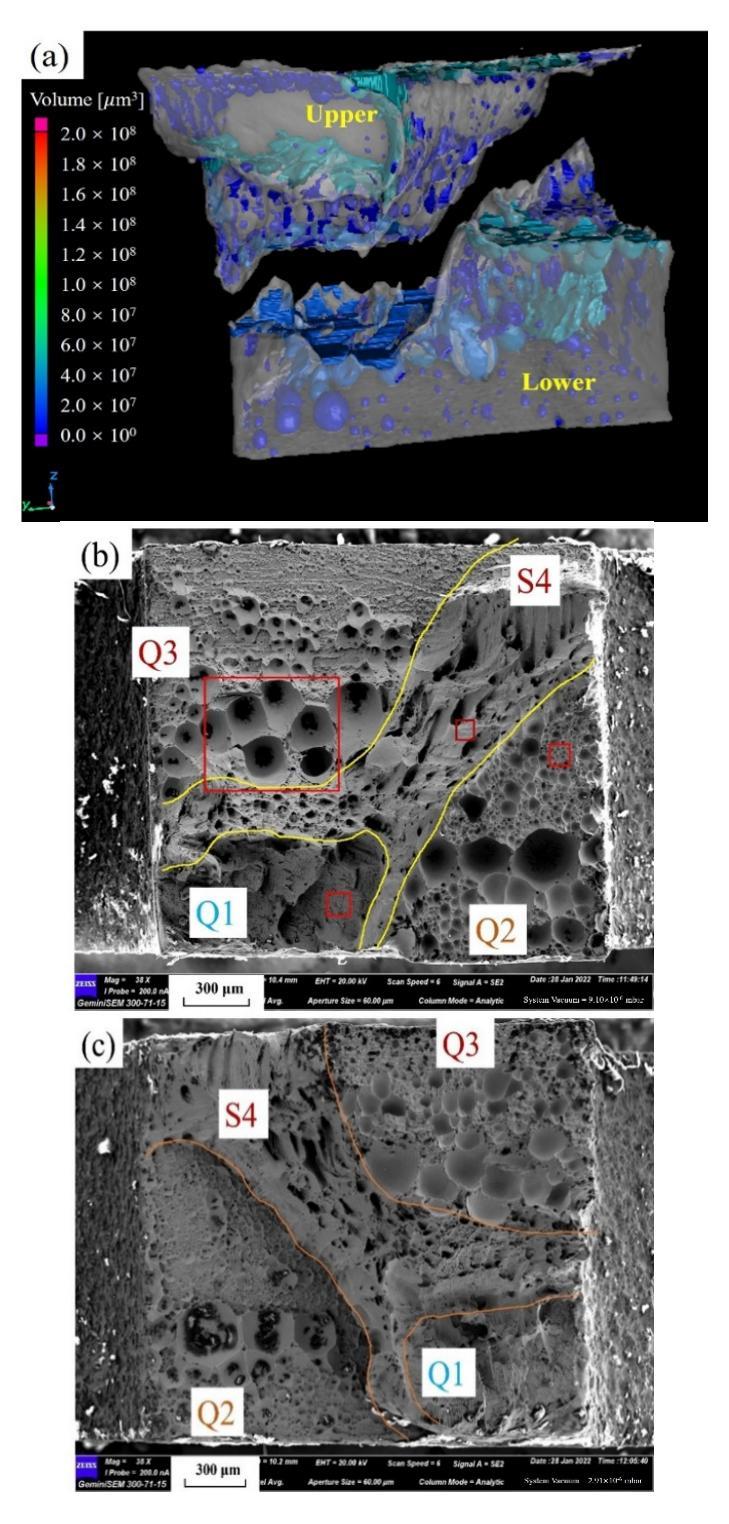
Figure 8. (a) Reconstruction of 3D internal structure of solder joint after fracture; (b) SEM fracture morphology of lower part; (c) SEM fracture morphology of upper part.

Figure 8a showed the 3D CT reconstruction morphology of the solder joints after the fractures. As could be seen, the final fracture morphology of the solder joint was relatively complex, and included the fracture surface of two IMC layers and the solder material itself. Figure 8b,c showed the fracture morphology of the lower and upper parts, respectively. According to the characteristics of the fracture morphology, it can be determined that a

As shown in Figure 8 of Section 3.3, the fracture morphology exhibited different characteristics in different regions. To better explain the fracture mechanism of the solder joint, the characteristic positions of different regions in Figure 8b were partially enlarged. Figure 13a showed an enlarged view of the flake surface in the Q1 region, and it could be seen that the smooth surface implies recrystallization characteristics. The formation mechanism of flakes in the Q1 region was effectively demonstrated. In regions Q2 and Q3, there were some spherical pores with diameters ranging from tens of microns to more than one hundred microns, and the partially enlarged view was shown in Figure 13b. As could be seen, owing to the small space among the pores, the final fracture morphology had pores with partial edges that were characterized by tearing, as shown in the red box in Figure 13b. Additionally, it was found that the tearing morphology of a single pore was polygonal, and

Additionally, in the partially enlarged image in Figure 8b, it can be seen that there were many microstructural characteristics besides the pore defect evolution in Figure 13c. First, the component distribution in Figure 13c was characterized by EDS mapping. The distributions of Sn, Cu, and Ag elements in the fracture surface were shown in Figure 14a–c, respectively. In Figure 14a, some small and bright dots were relatively evenly distributed in the whole area. However, the Cu element distribution in Figure 14b was not uniform, and the positions of the bright spots were consistent with those of the prismatic particles in Figure 13c. In order to determine the material type of the particles, quantitative analysis was performed on the particles at point 1 in Figure 14b, as shown in Figure 14d. Thus, from the component ratio, it could be determined that the prism particles are the Cu₅Sn₆ phase, which proved that the fracture surfaces of regions Q2 and Q3 were IMC layers. Overall, the IMC layers became the weak link between the SAC305 solder and the Cu bar. Another reason was that a large concentration of stress existed on the lower and upper IMC

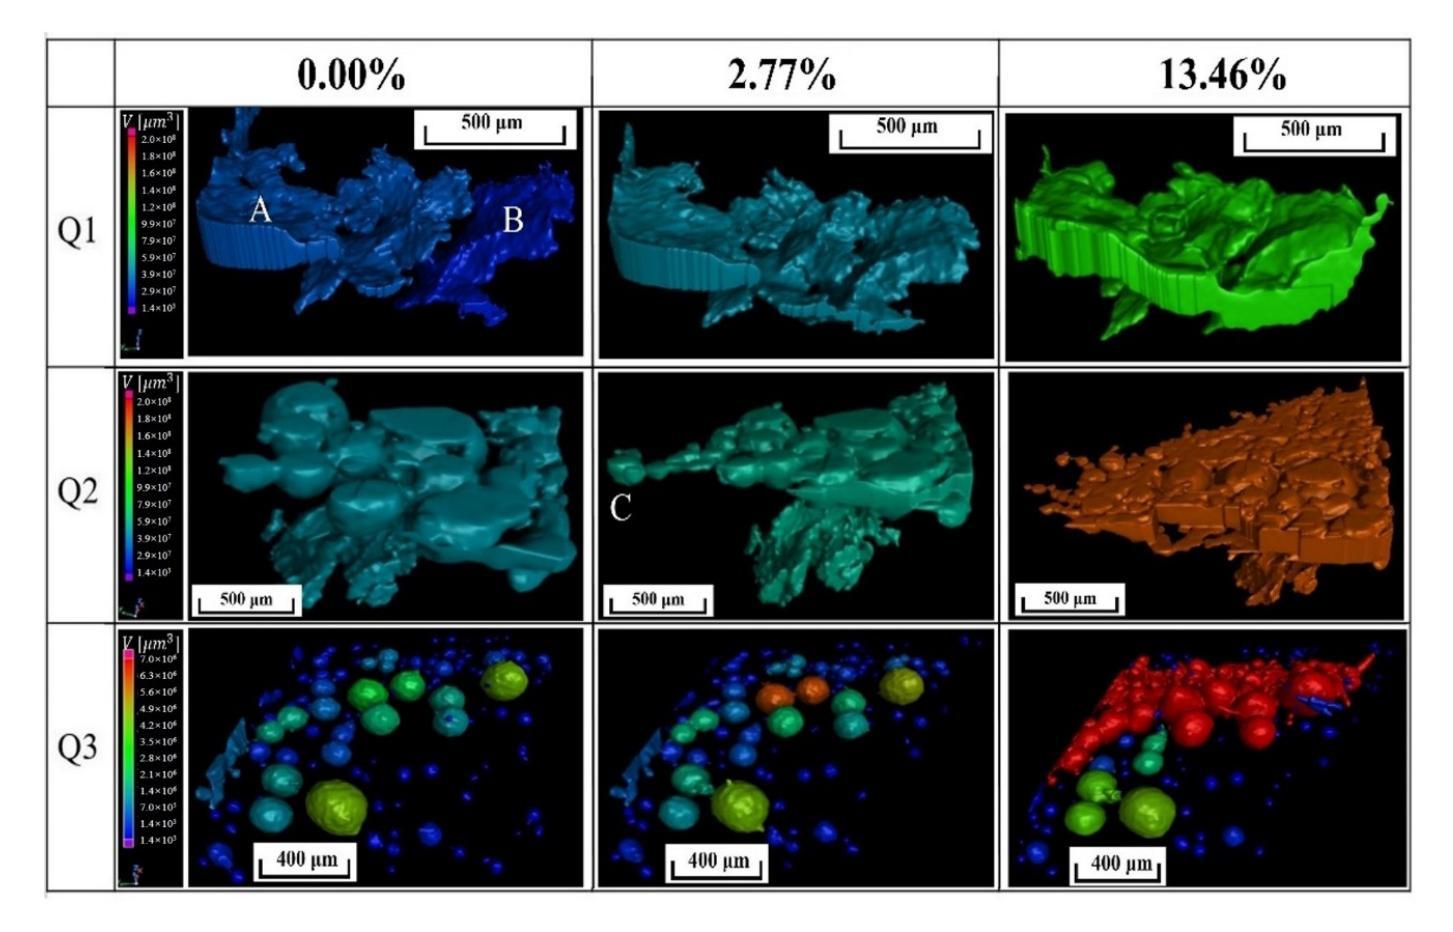
Figure 9. Evolution of 3D defects as strain increased in three regions of solder joints.

To quantitatively describe the evolution of the internal pores during the tensile process of the Cu/SAC305/Cu solder joints, the defects in three regions (Q1, Q2, and Q3), respectively, were extracted as shown in Figure 9. In the Q1 region, two flake defects mainly existed, and were marked as A and B, respectively. Defect A was connected to the outer surface, and defect B was an internal defect. At the initial state, the two defects in region Q1 were separated. When the deformation reached 2.77%, defects A and B connected. When the deformation was 13.46%, the thickness and volume of the defect significantly increased. Region Q2 was an aggregated pore defect close to the IMC layer. The pores partially connected in the soldering process. As the strain increased to 2.77%, the pores continued to spread forward and "swallowed" a small pore (C). When the strain reached 13.46%, the crack propagated further, and the propagation direction was perpendicular to the loading. Region Q3 consisted of aggregated spherical pores near the IMC layer. However, it could be seen that these pores were not connected and remained in a separated state. When the strain reached 2.77%, the spherical pores grew, but an obvious connection phenomenon did not exist. When the strain increased to 13.46%, some spherical pores began to connect and aggregate.

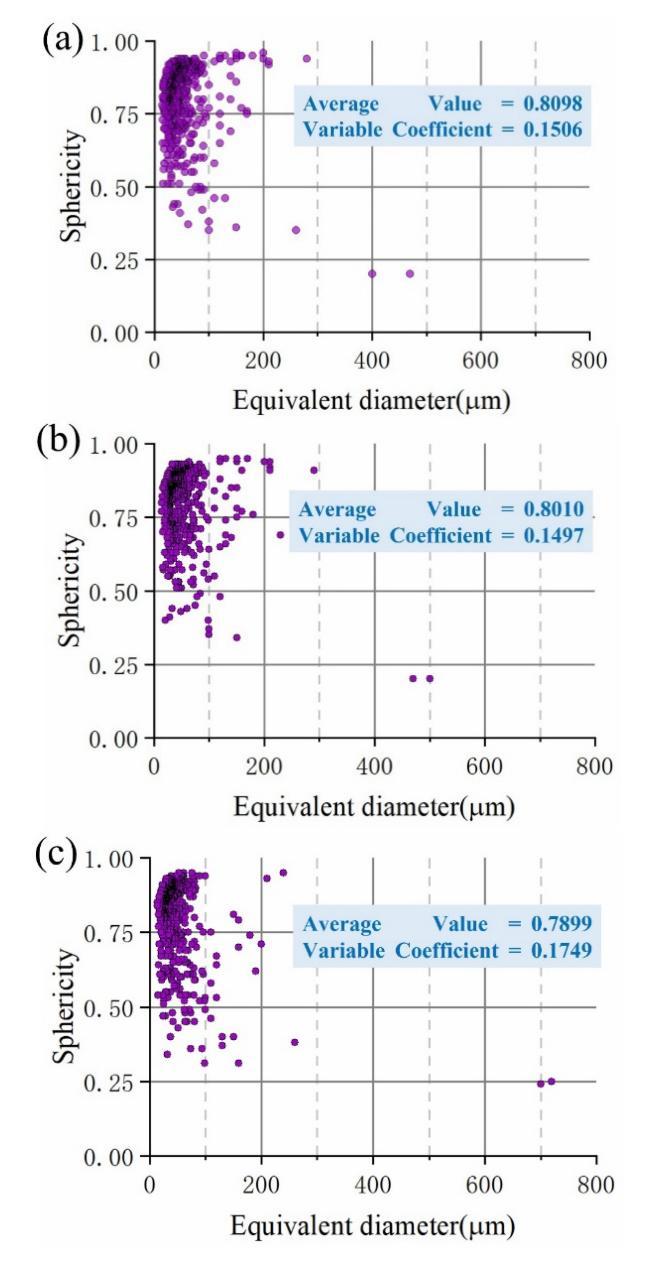
Figure 10. Sphericity distribution of defects at solder joints under different deformation states: (a) 0.00; (b) 2.77%; (c) 13.46%.

The volume and shape evolution of the internal defects were quantitatively characterized. Generally, the shape characteristics of the defects were characterized by the sphericity parameters, that is, the ratio between the spherical surface, which was the same as the volume of the defect, and the defective surface [32]. Figure 10 showed the sphericities of the defects in the solder joint under different strain conditions. As could be seen, the average sphericity decreased as the deformation increased, which indicated that the defect shape was changing. The variation of the normalized dispersions (variable coefficient) in the crack propagation and final fracture zone (II) was greater than that in the deformation zone (I). The total volume, general surface, and volume ratio of the defects were also quantitatively characterized, as presented in Table 2. As can be seen, as the deformation gradually increased, the growth rate of the total volume, the general surface area, and the defect volume ratio of the defects in the crack propagation were greater than those in the deformation zone.

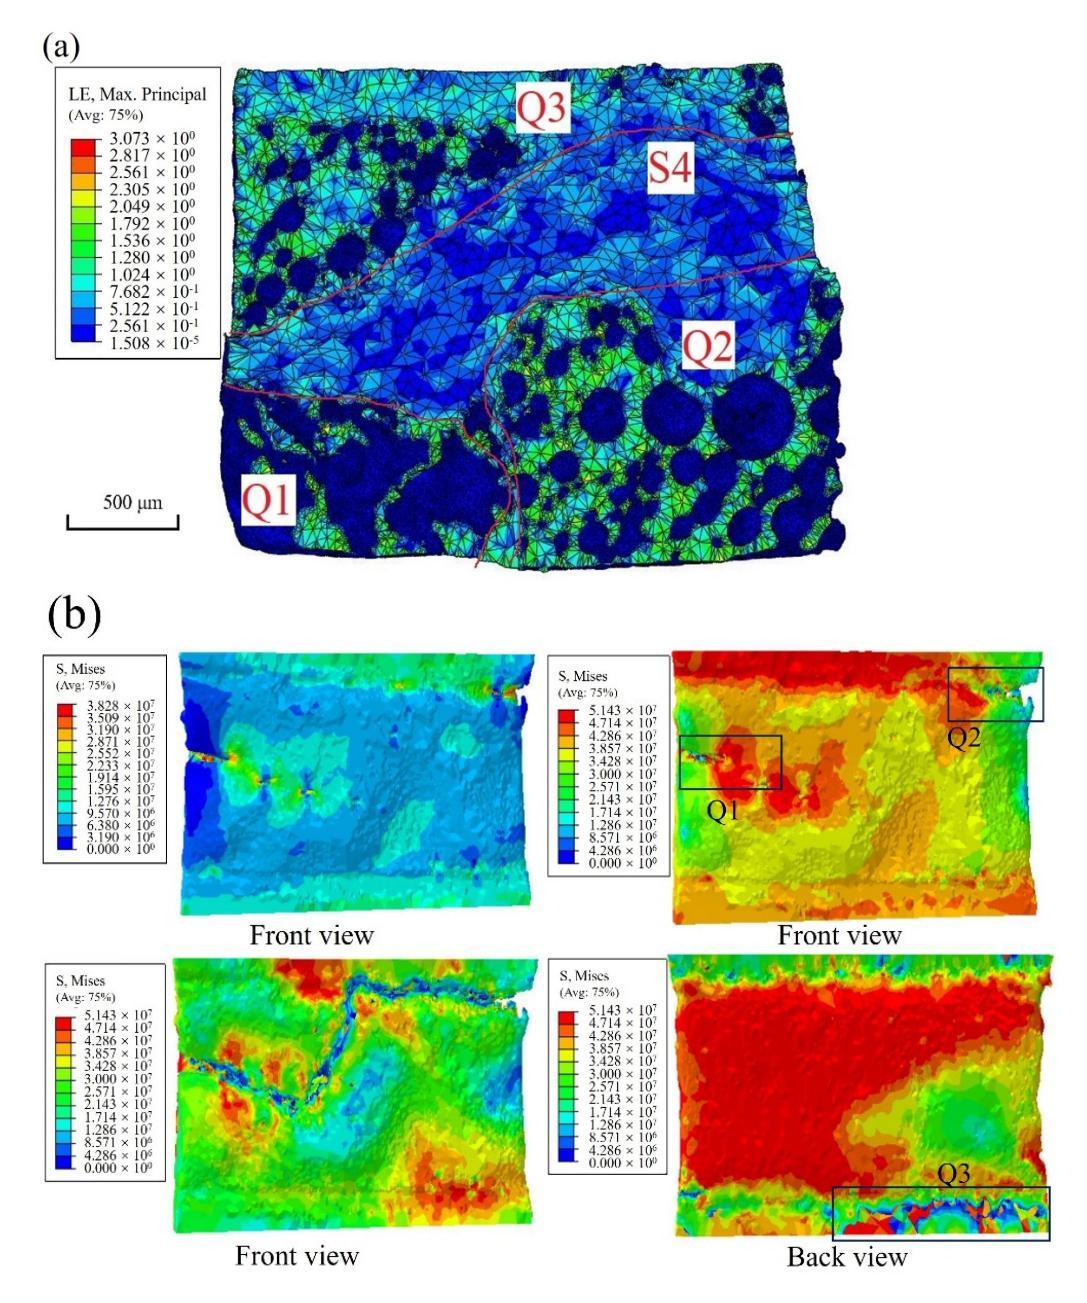
Figure 11. FE simulation results: (a) fracture morphology of solder joints; (b) process of crack initiation and propagation for solder joints.

Figure 11 showed the simulation results for the fracture surface and crack growth. As shown in Figure 11a, the fracture morphology was divided into four zones: Q1, Q2, and Q3 were tensile fracture zones, and S4 was a shear fracture zone, similar to the experimental results shown in Figure 8b. Figure 11b showed the simulation results for the crack propagation process under different displacement loading conditions, which revealed that the crack was first initiated and propagated from the defects in regions Q1 and Q2. However, the crack in region Q2 was propagated faster along the direction perpendicular to the loading direction during the continuous tensile process. The reliability of the simulation results was verified as shown in Figure 8c. In summary, the propagation path and the rate of cracks were closely related to the distribution of the internal defects of the solder joints, as discussed in detail in Section 4.1.

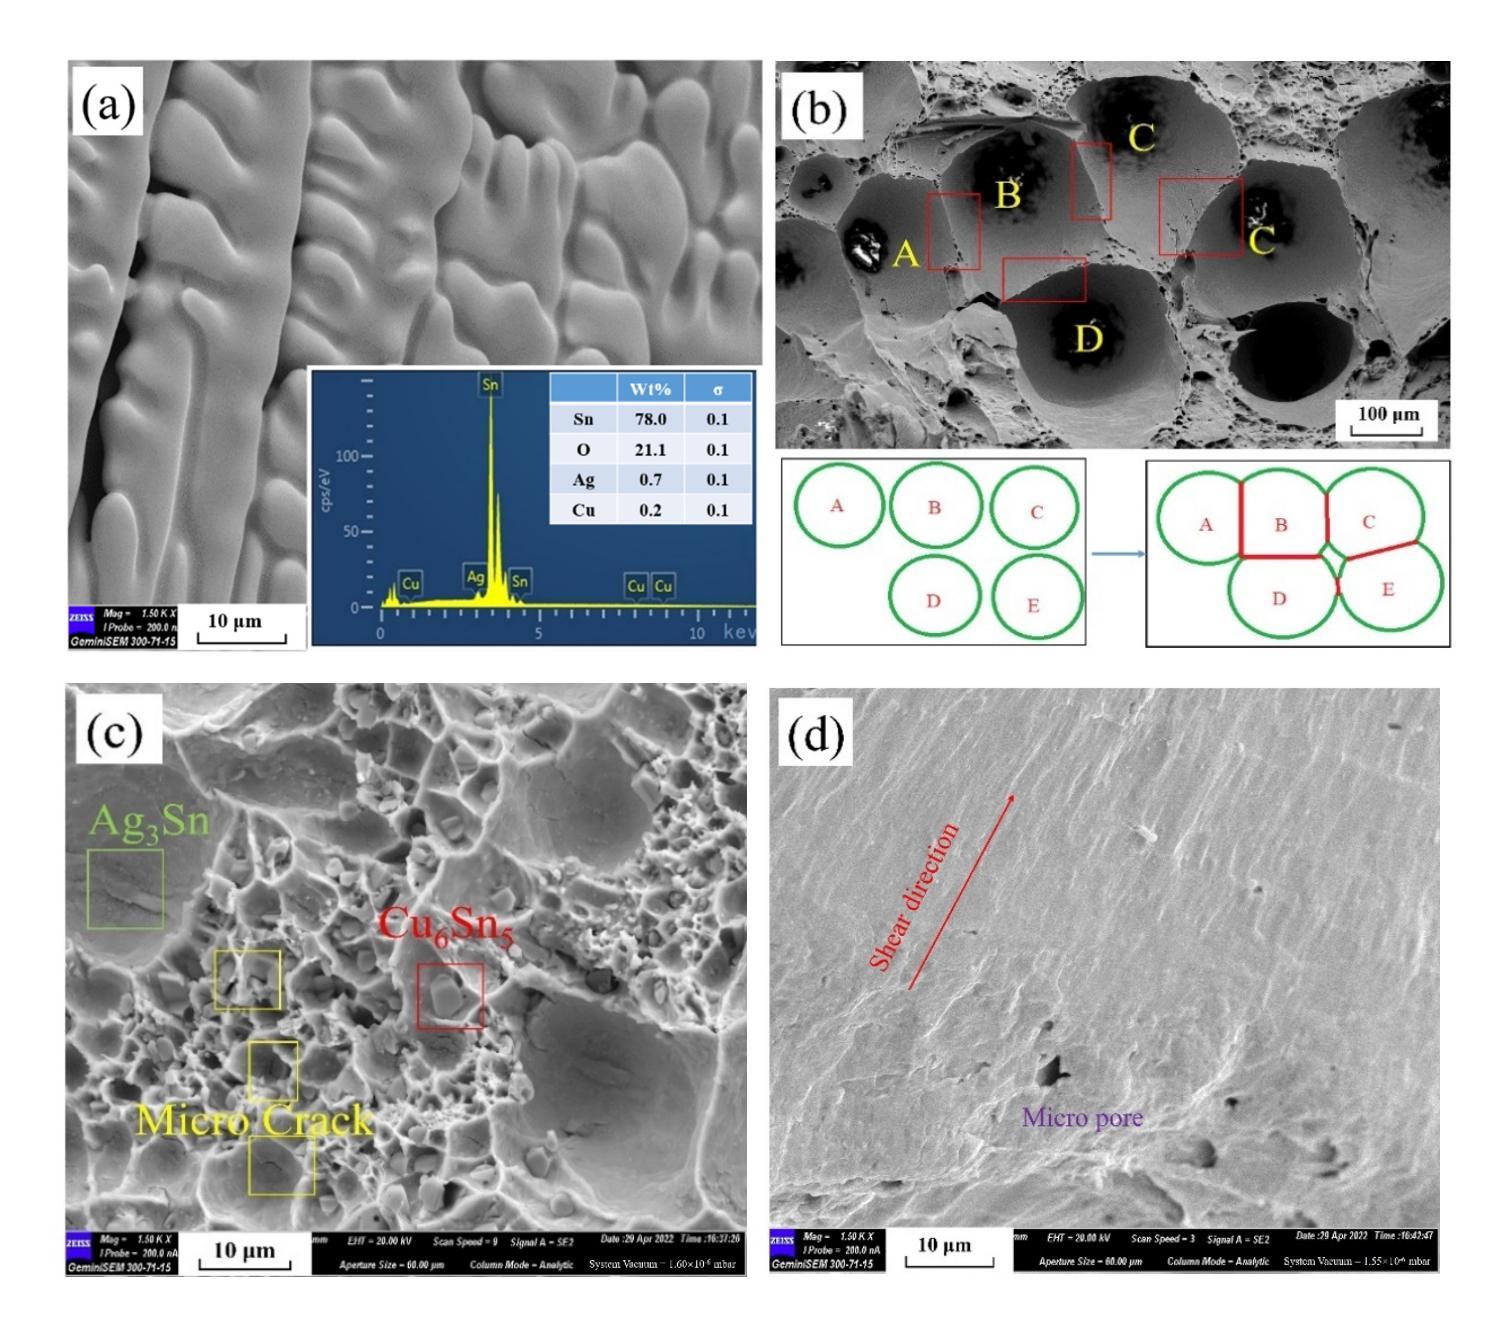
Figure 13. Partially enlarged image: (a) Q1 region; (b) pores in Q3 region; (c) fracture surface of IMC layer in Q2 region; (d) S4 region.

layers, owing to the aggregation of the pores. Additionally, interface debonding between the Cu₆Sn₅ particles and the β -Sn matrix was observed on the fracture surface, as shown in Figure 13c. Tang et al. [45] reported that the elastic modulus of the Cu₆Sn₅ phase was approximately three times equal to that of the β -Sn matrix. Therefore, the deformation between the Cu₆Sn₅ phase and the β -Sn matrix was inconsistent during the tensile process. Additionally, various microcracks were formed on the fracture surface owing to the large local stress caused by the inconsistent deformation. As mentioned earlier, the fracture morphology of the S4 region was mainly the shear area, and the partial enlarged view is shown in Figure 13d. Since it mainly existed inside the SAC305 alloy, there were no prismatic particles. The shearing direction could be determined from the streamline in Figure 13d.

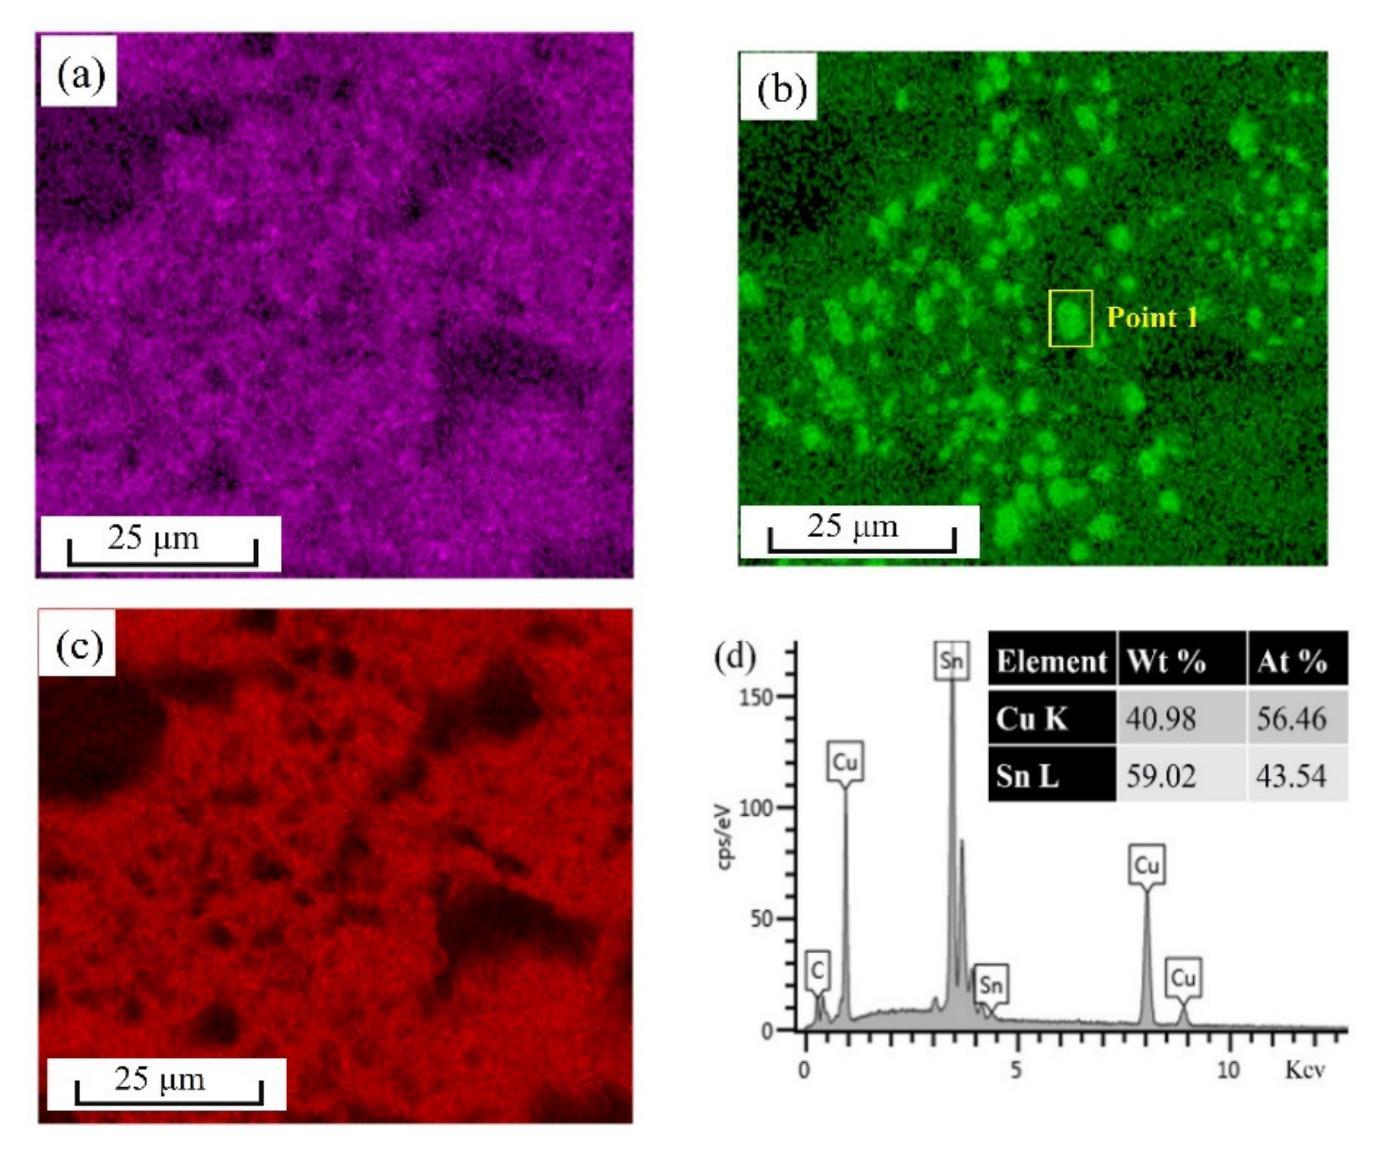
Figure 14. EDS mapping of fracture surface of IMC layer in Q2 region: (**a**) Ag element; (**b**) Cu element; (**c**) Sn element; (**d**) component ratio of prism particles at point 1.
